# **APPENDIX A**

## **FIELD INVESTIGATION NOTES**

# Geomorphic Analysis Check List

Site Name: Lower Rush River - 1

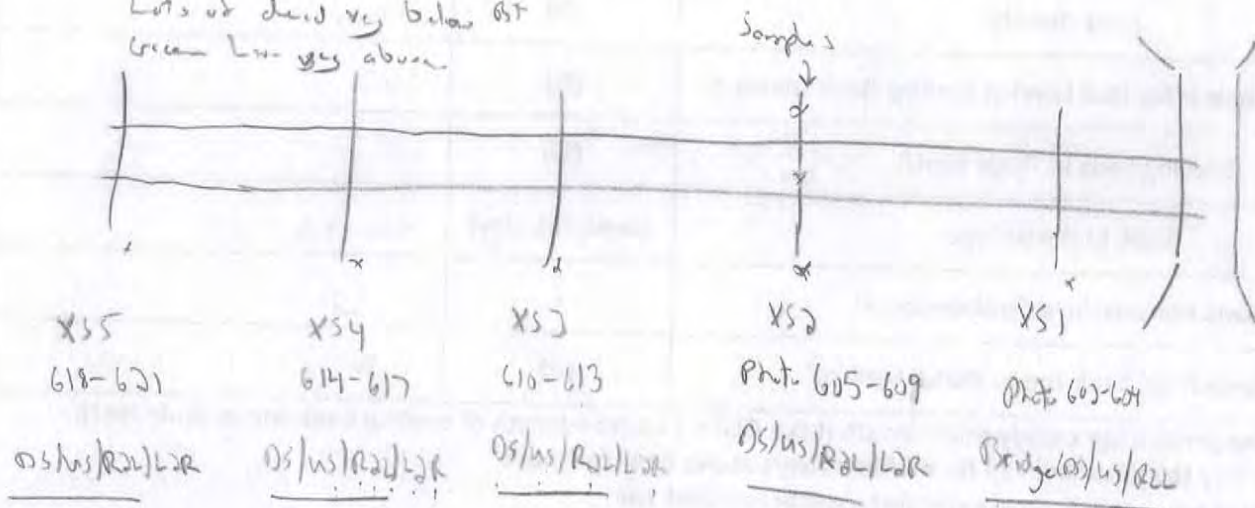
BF Note: Based on Veg  
TB influenced by rd + Field due  
to man-made ditch

Org during visit  
Lots of dead veg below BT  
Green Lm-veg above

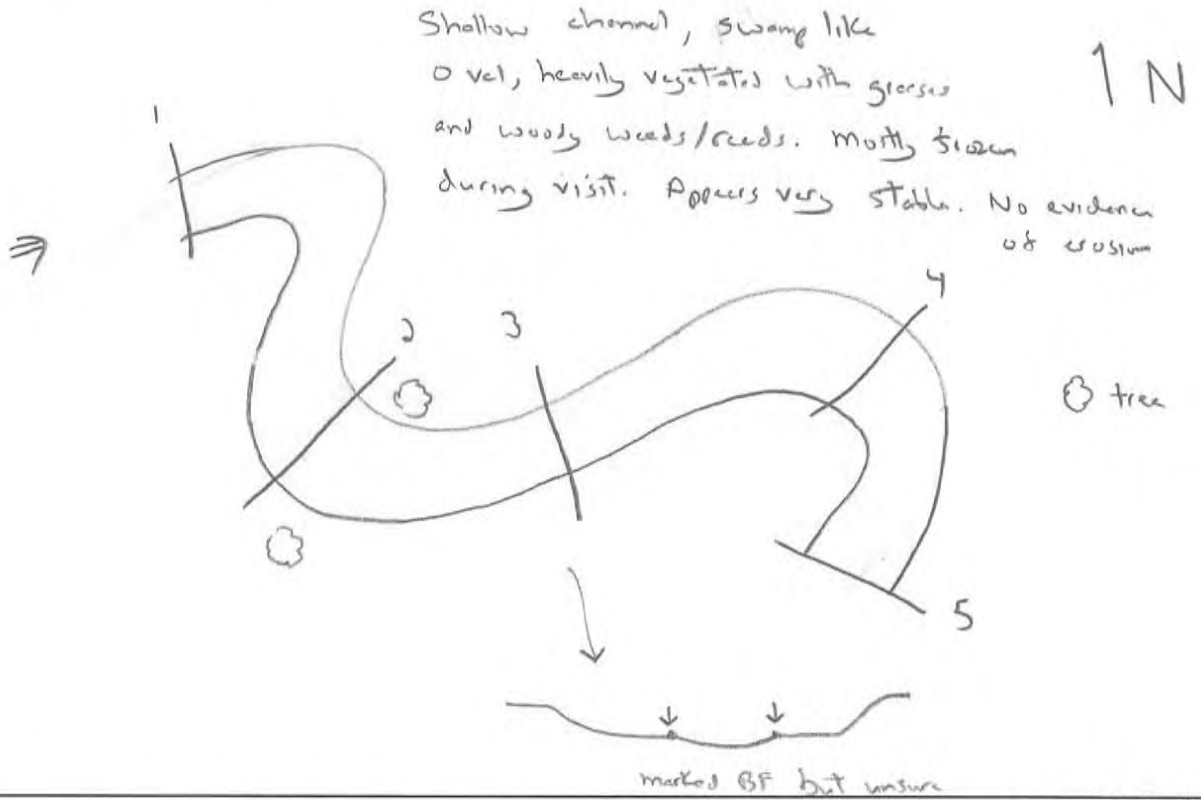
FID 9 (RMG.50-6.03)

Survey crew did not  
 find. Did not resurvey  
 in 2011 as G = 0

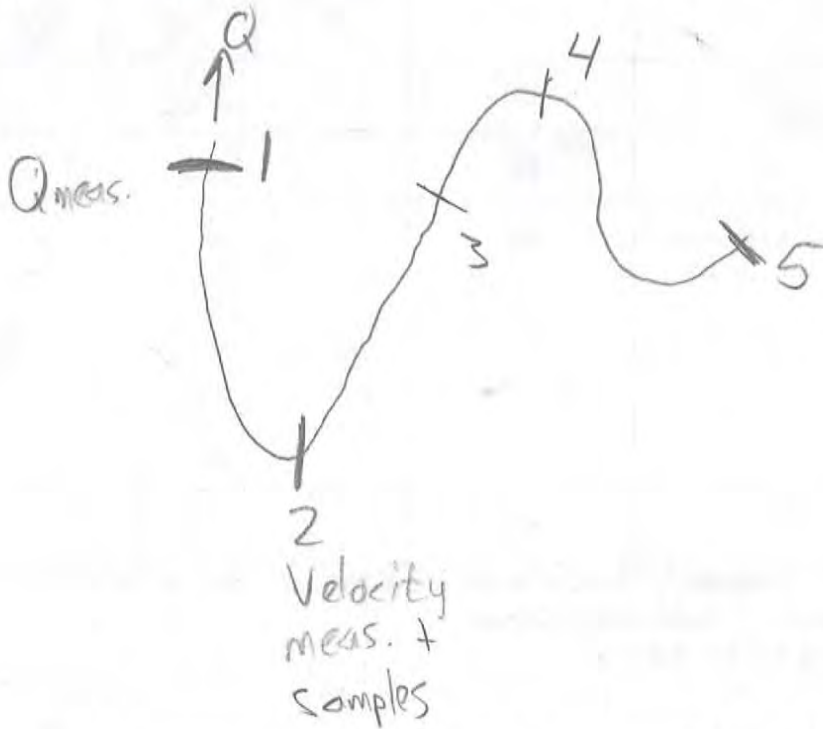
Sample from channel center was hard-packed clay as was bed near RB. RB sample was darker in color than central channel bed sed. sample. Light layer of sand on both samples.

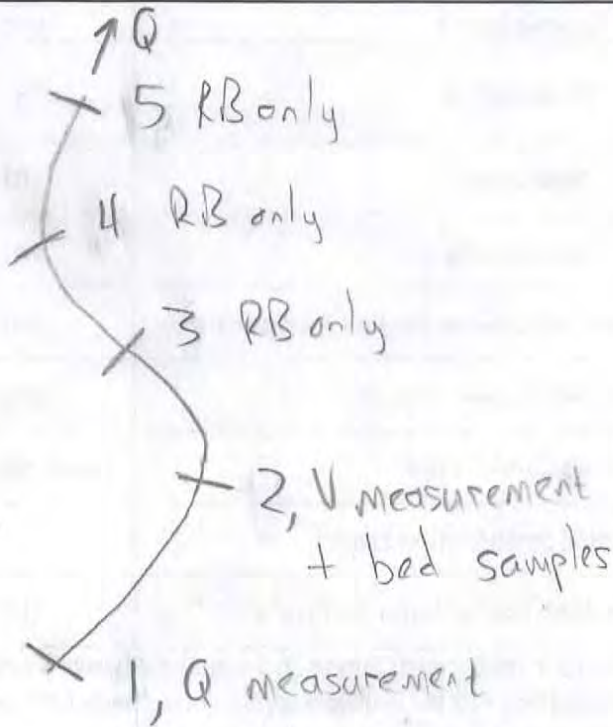
Sample from channel thalweg was medium colored clay w/ very little sand on top.  
 Sample from near LB on the 'shelf' was primarily sand. Top portion was a lighter colored sand and bottom portion was a darker sand/clay mix.
