Long Term Performance of a Sunflower Oil/Diesel Fuel Blend

M. ZIEJEWSKI AND K. R. KAUFMAN

The purpose of this project was to study the effects of a 50 percent blend by volume of sunflower oil in #2 diesel fuel used in a diesel test engine of current design. Specifically, this investigation covered the effect of the fuel blend on engine durability and the functioning of the different fuels in the diesel engine injection system.

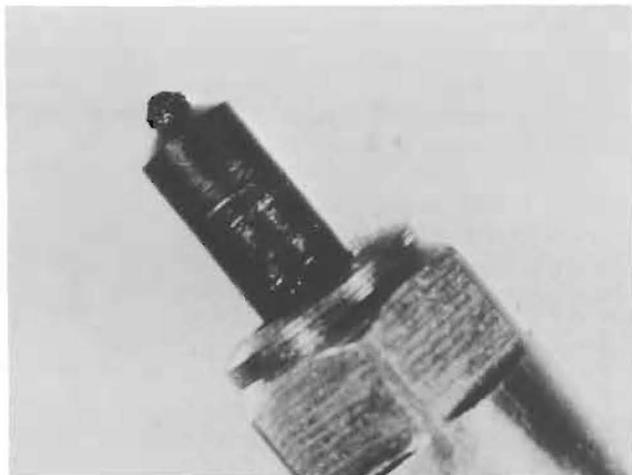
After a short period of time, the test on the 50/50 mixture showed excessive carbon buildup on the nozzle tip (Fig. 3). Partly responsible for the carbon buildup on the nozzle are the following: (1) the sunflower oil tendency to polymerize, (2) a small quantity of fuel which remains at the nozzle tip after the end of the main injection, and later (3) injection nozzle "micro" reopens, (4) secondary injection and (5) needle sticking.

nozzle tip owing to fuel evaporation at the high temperatures and the high gas flow (9). The fuel trapped between injections undergoes decomposition from high temperatures. This decomposition of the fuel occurs at a temperature of 660°F (350°C) and is influenced by the chemical composition of the fuel and the presence of catalytic materials, one of which is carbon (10).

Fig. 3—Injection nozzle tip after 24 hours of testing with a 50/50 sunflower oil/diesel fuel mixture.

The carbon did not build up equally around the nozzle tip of the 32 nozzles which were tested. The carbon distribution shows a pattern which was consistent in all tested nozzles. The nozzle orifice on the intake valve side was almost clean. There was no carbon buildup on the surface and much less inside the orifice. The remaining nozzle surface showed considerable carbon buildup which extended into the orifices. It is very possible that air swirl movement had an influence on the carbon distribution of the nozzle tip. There are also different angles between the nozzle holes and the main axis of the nozzle tip. The different angles could cause differences in dynamic flow through the orifices. This could cause a difference in injection velocity and flow pattern of the injected fuel resulting in a variation of fuel spray configuration (11).

Carbon deposits developed inside the nozzle orifices causing a decrease in the orifices' diameter and affecting smoothness of the orifices' surfaces. Inspection showed a reduction in orifice diameters for all tested nozzles. For each nozzle, three orifices exhibited a reduction of inside diameter from 0.0125 inch to 0.0108 inch. The orifice on the intake valve side showed a reduction of inside diameter from 0.0125 inch to 0.0118 inch. This translates to a total hole area reduction of approximately 25 percent.

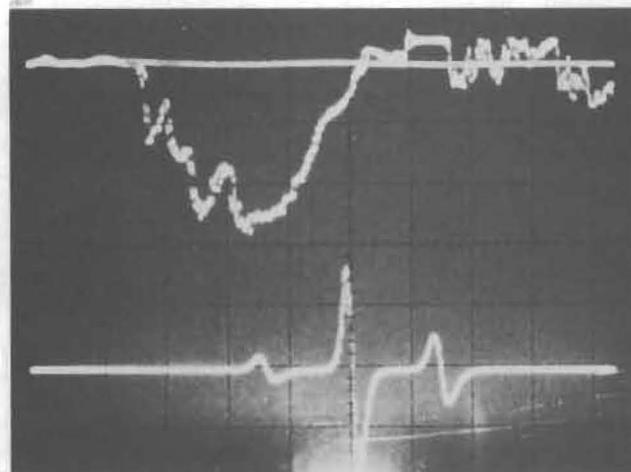
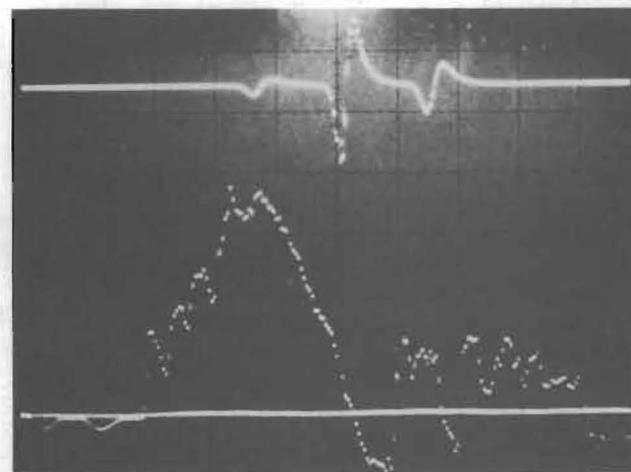
Maximum injection line pressure and residual line pressure increased due to the reduction in orifice diameters caused by the carbon deposits (Figs. 4 and 5). The increased maximum line pressure caused a higher rate at which the fuel was injected into the combustion

chamber and thus affected the rate of pressure rise. Higher residual line pressure, in addition to the decrease in opening pressure, increased the possibility of secondary injection. Maximum injection pressure at 2300 RPM increased from 6500 psi for a clean nozzle to 9000 psi for a carboned nozzle and at 1800 RPM from 6000 psi (clean nozzle) to 7000 psi (carboned nozzle). Residual line pressure went up from 2900 psi to 4500 psi at 2300 RPM and from 2500 psi to 3000 psi at 1800 RPM. The residual pressure waves for the carboned nozzle also occurred sooner than for the clean nozzle. Therefore, for the carboned nozzle, successive residual line pressure waves occurred at higher combustion chamber pressures, increasing the possibility of needle micro-reopening and secondary injection.

Fig. 4—Timing mark (1) and injection line pressure (2) at the nozzle for 50/50 sunflower oil/diesel fuel mixture after 2 hours of operation. Nozzle opening pressure = 4250 psi. Engine speed = 2300 RPM. Nozzle has four orifices with a diameter of 0.0125 in.

Fig. 5—Timing mark (1) and injection line pressure trace (2) at the nozzle for 50/50 sunflower/diesel fuel mixture after 108 hours of engine operation. Nozzle opening pressure = 4000 psi. One nozzle orifice completely plugged. Two orifices have a diameter of 0.01/in. One orifice has a diameter of 0.012 in. Engine speed = 2300 RPM.

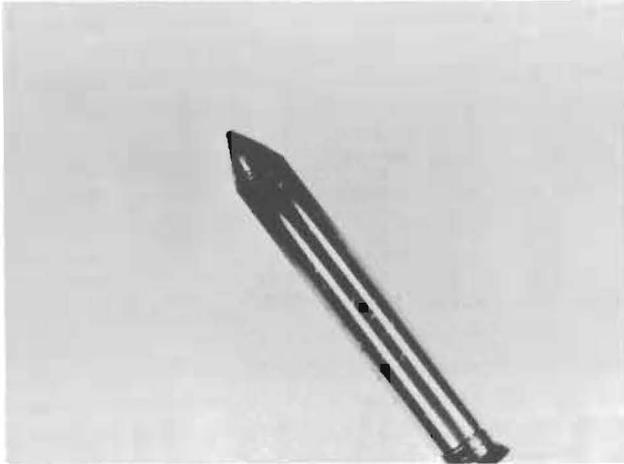
This phenomenon does not affect the specific fuel consumption, but it can cause the formation of carbon deposits on the nozzle tip. The formation of carbon deposits on the injector needle (Fig. 6) and seat may cause poor seating with consequent dribble.

Fig. 6—Carbon buildup on the injection needle after 25 hours of testing with a 50/50 sunflower oil/diesel fuel mixture.

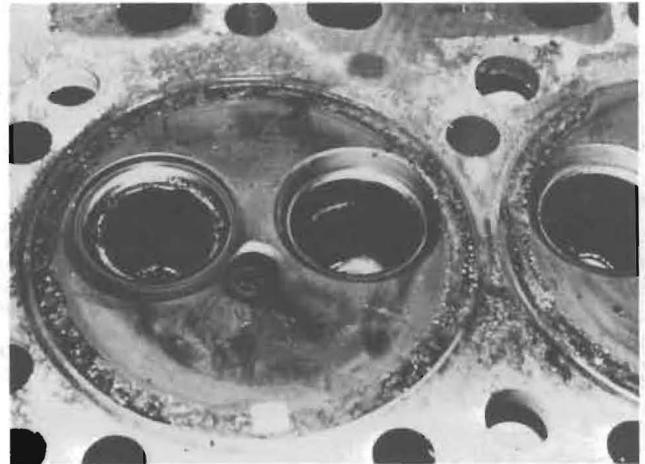
After 250 hours of testing, excessive carbon buildup on the cam side of the intake ports was noticed (Fig. 7). This phenomenon was caused by many factors: 1) the sunflower oil tendency to polymerize, 2) the combustion process in the second stage of combustion and after-burning (especially at light load), and 3) the effect of valve timing. The combustion must be completed early in the expansion stroke so that the temperature is high enough that oxygen can react with the carbon monoxide, hydrogen, and soot to form the desired products. If the combustion occurs later in the expansion stroke, less

time is available before the exhaust valve opens and the temperature has dropped to a value too low for rapid oxidation.

Fig. 7—Carbon buildup on the intake port after 250 hours of testing with a 50/50 sunflower oil/diesel fuel mixture.

The valve timing chosen for a particular engine is generally a compromise of scavenging and the effect on power and torque curves, maximum permissible temperatures of internal working parts, and overall engine efficiency. The value overlap was 36° in this test engine. The quantity of air flow through the cylinder during the overlap period is a function of P_e/P_i (exhaust pressure/intake pressure) and the exhaust gas kinetic energy. In a turbocharged diesel engine, P_e/P_i exceeds unity under the conditions of a suddenly increased load. This encourages exhaust gas to flow through the cylinder into the intake port during the valve overlap period and cause carbon buildup.

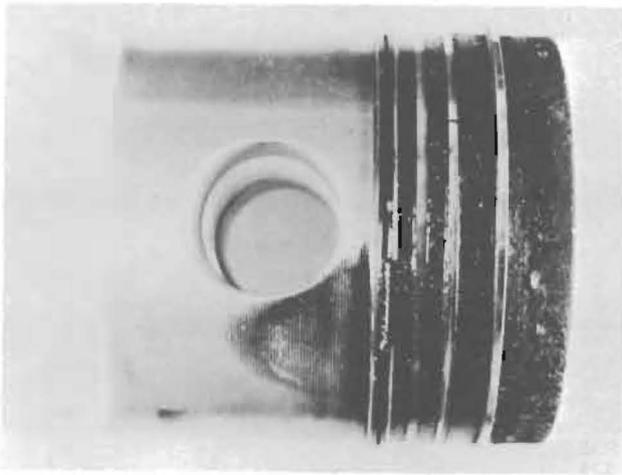
After 245 hours of engine operation on the 50/50 blend, piston rings #2 and #3 were stuck and the #4 ring (oil ring) was broken on the #1 piston (Fig. 9). The cylinder was gouged out on the major and minor thrust side and was scratched throughout (Fig. 10). The top of

Fig. 9—Carbon buildup on the piston. Rings #2 and #3 are stuck. Ring #4 (oil ring) is broken after 245 hours of engine operation with a 50/50 sunflower oil/diesel fuel mixture.

the cylinder block was carboned up between cylinders indicating poor sealing. Furthermore, excessive carbon buildup in the intake port was noticed. After this failure, the cylinder head, cylinder sleeves, pistons and rings were replaced.

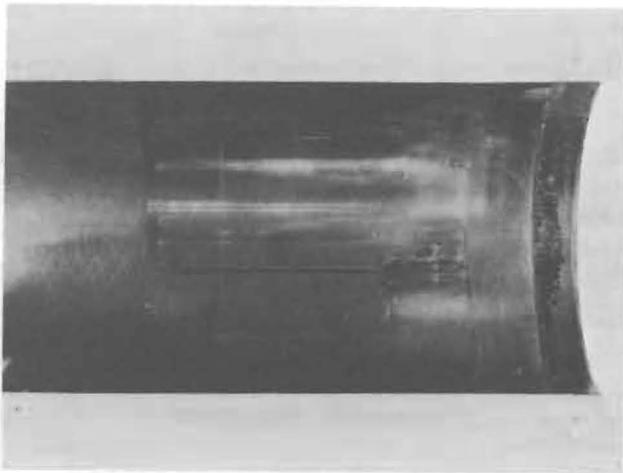
Fig. 10—Cylinder liner wear on the major thrust side after 245 hours of engine operation with a 50/50 sunflower oil/diesel fuel mixture.

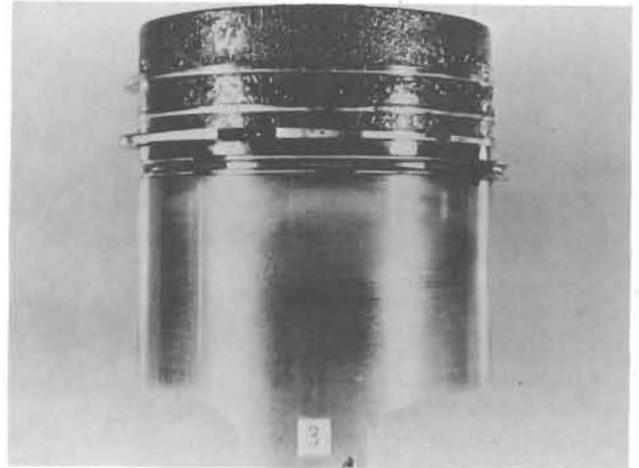
After 604 hours on the 50/50 mixture, a piston failure, which was not caused by the fuel, ended the test. All pistons showed heavy carbon buildup around the ring groove on the top land. Normal carbon buildup on the second land was observed. Carbon and varnish residue on the third and fourth land was also evident (Fig. 11). Piston ring side clearance was measured after the test and after cleaning. The top ring side clearance increased from 0.003 inch to 0.005 inch. The second rings were all stuck and could not be measured. For the third ring, a large change of inside clearance occurred only on the #4 piston where side clearance increased

Fig. 11—Carbon buildup on the piston and a stuck #2 ring after 604 hours of engine operation with a 50/50 sunflower oil/diesel fuel mixture.

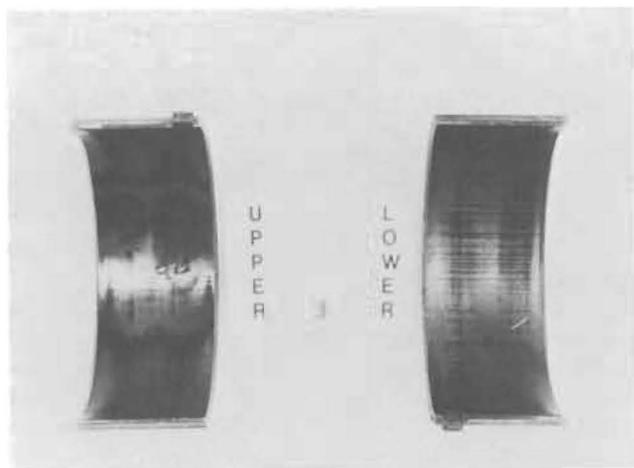
Except for light scratches in the #1 and #5 lower main bearings, they were in very good condition. The #2 upper rod bearings showed light edge loading while the #1 and #4 upper rod bearings showed completely removed overlay on the bearing surface in spots. Further, on the #3 upper rod bearing, fatigue failure and a 1 inch visible crack could be seen (Fig. 12).

Fig. 12—Fatigue failure and partially removed overlay on the bearing surface of the #3 upper rod bearing after 604 hours of engine operation with a 50/50 sunflower oil/diesel fuel mixture.

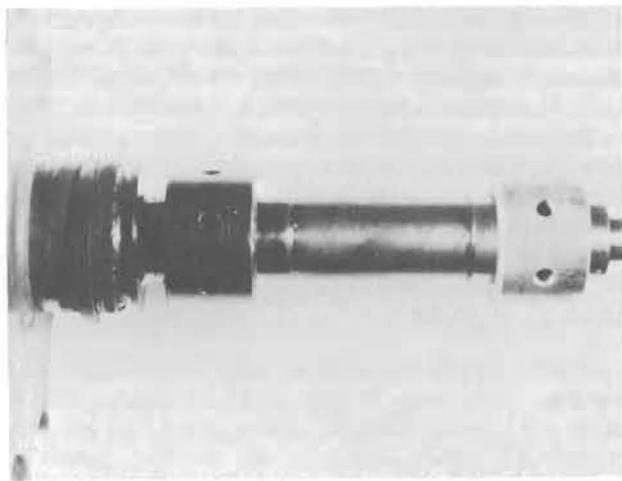
After 233 hours of engine operation, an engine instability problem (especially at a lower speed) led to inspection of the turbocharger. The turbine end journal bearing was seized on the turbine shaft due to inadequate lubrication. The shaft showed signs of severe oil coking (Fig. 13). The thrust collar and thrust bearings were mechanically in good condition, but they were discolored by oil coking. The failed turbocharger was replaced by a new one. At the end of the test (604 hours) on the 50/50 mixture the second turbocharger was inspected and again oil coking on the shaft was seen.

Fig. 13—Turbine and journal bearing seized on the turbine shaft. The shaft shows signs of severe oil coking after 233 hours of engine operation with a 50/50 sunflower oil/diesel fuel mixture.

13. A failed turbocharger was replaced after 233 hours of engine operation on the 50/50 blend. The turbine end journal bearing was seized on the turbine shaft due to inadequate lubrication. The shaft showed signs of severe oil coking.

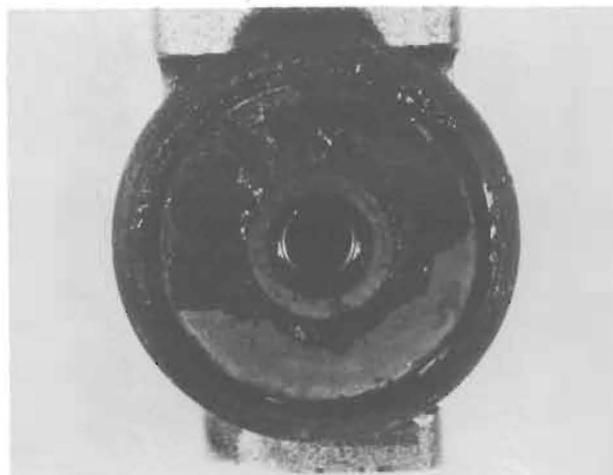
Although failure at this point was not imminent, future life for this turbocharger could not be predicted. The center housing of the turbocharger was coated with a soft carbon that seemed to build up, flake off, and rebuild (Fig. 14). In comparison, the center housing of the turbocharger after the run with #2 diesel fuel had a hard, thin carbon coating.

Fig. 14—Center housing of the turbocharger coated with soft carbon after 233 hours of engine operation with a 50/50 sunflower oil/diesel fuel mixture.
