A Wetlands  
Research Center

Erin Saarela  
Fall 2013 Studio  
Arch 7721  
Mark Barnhouse

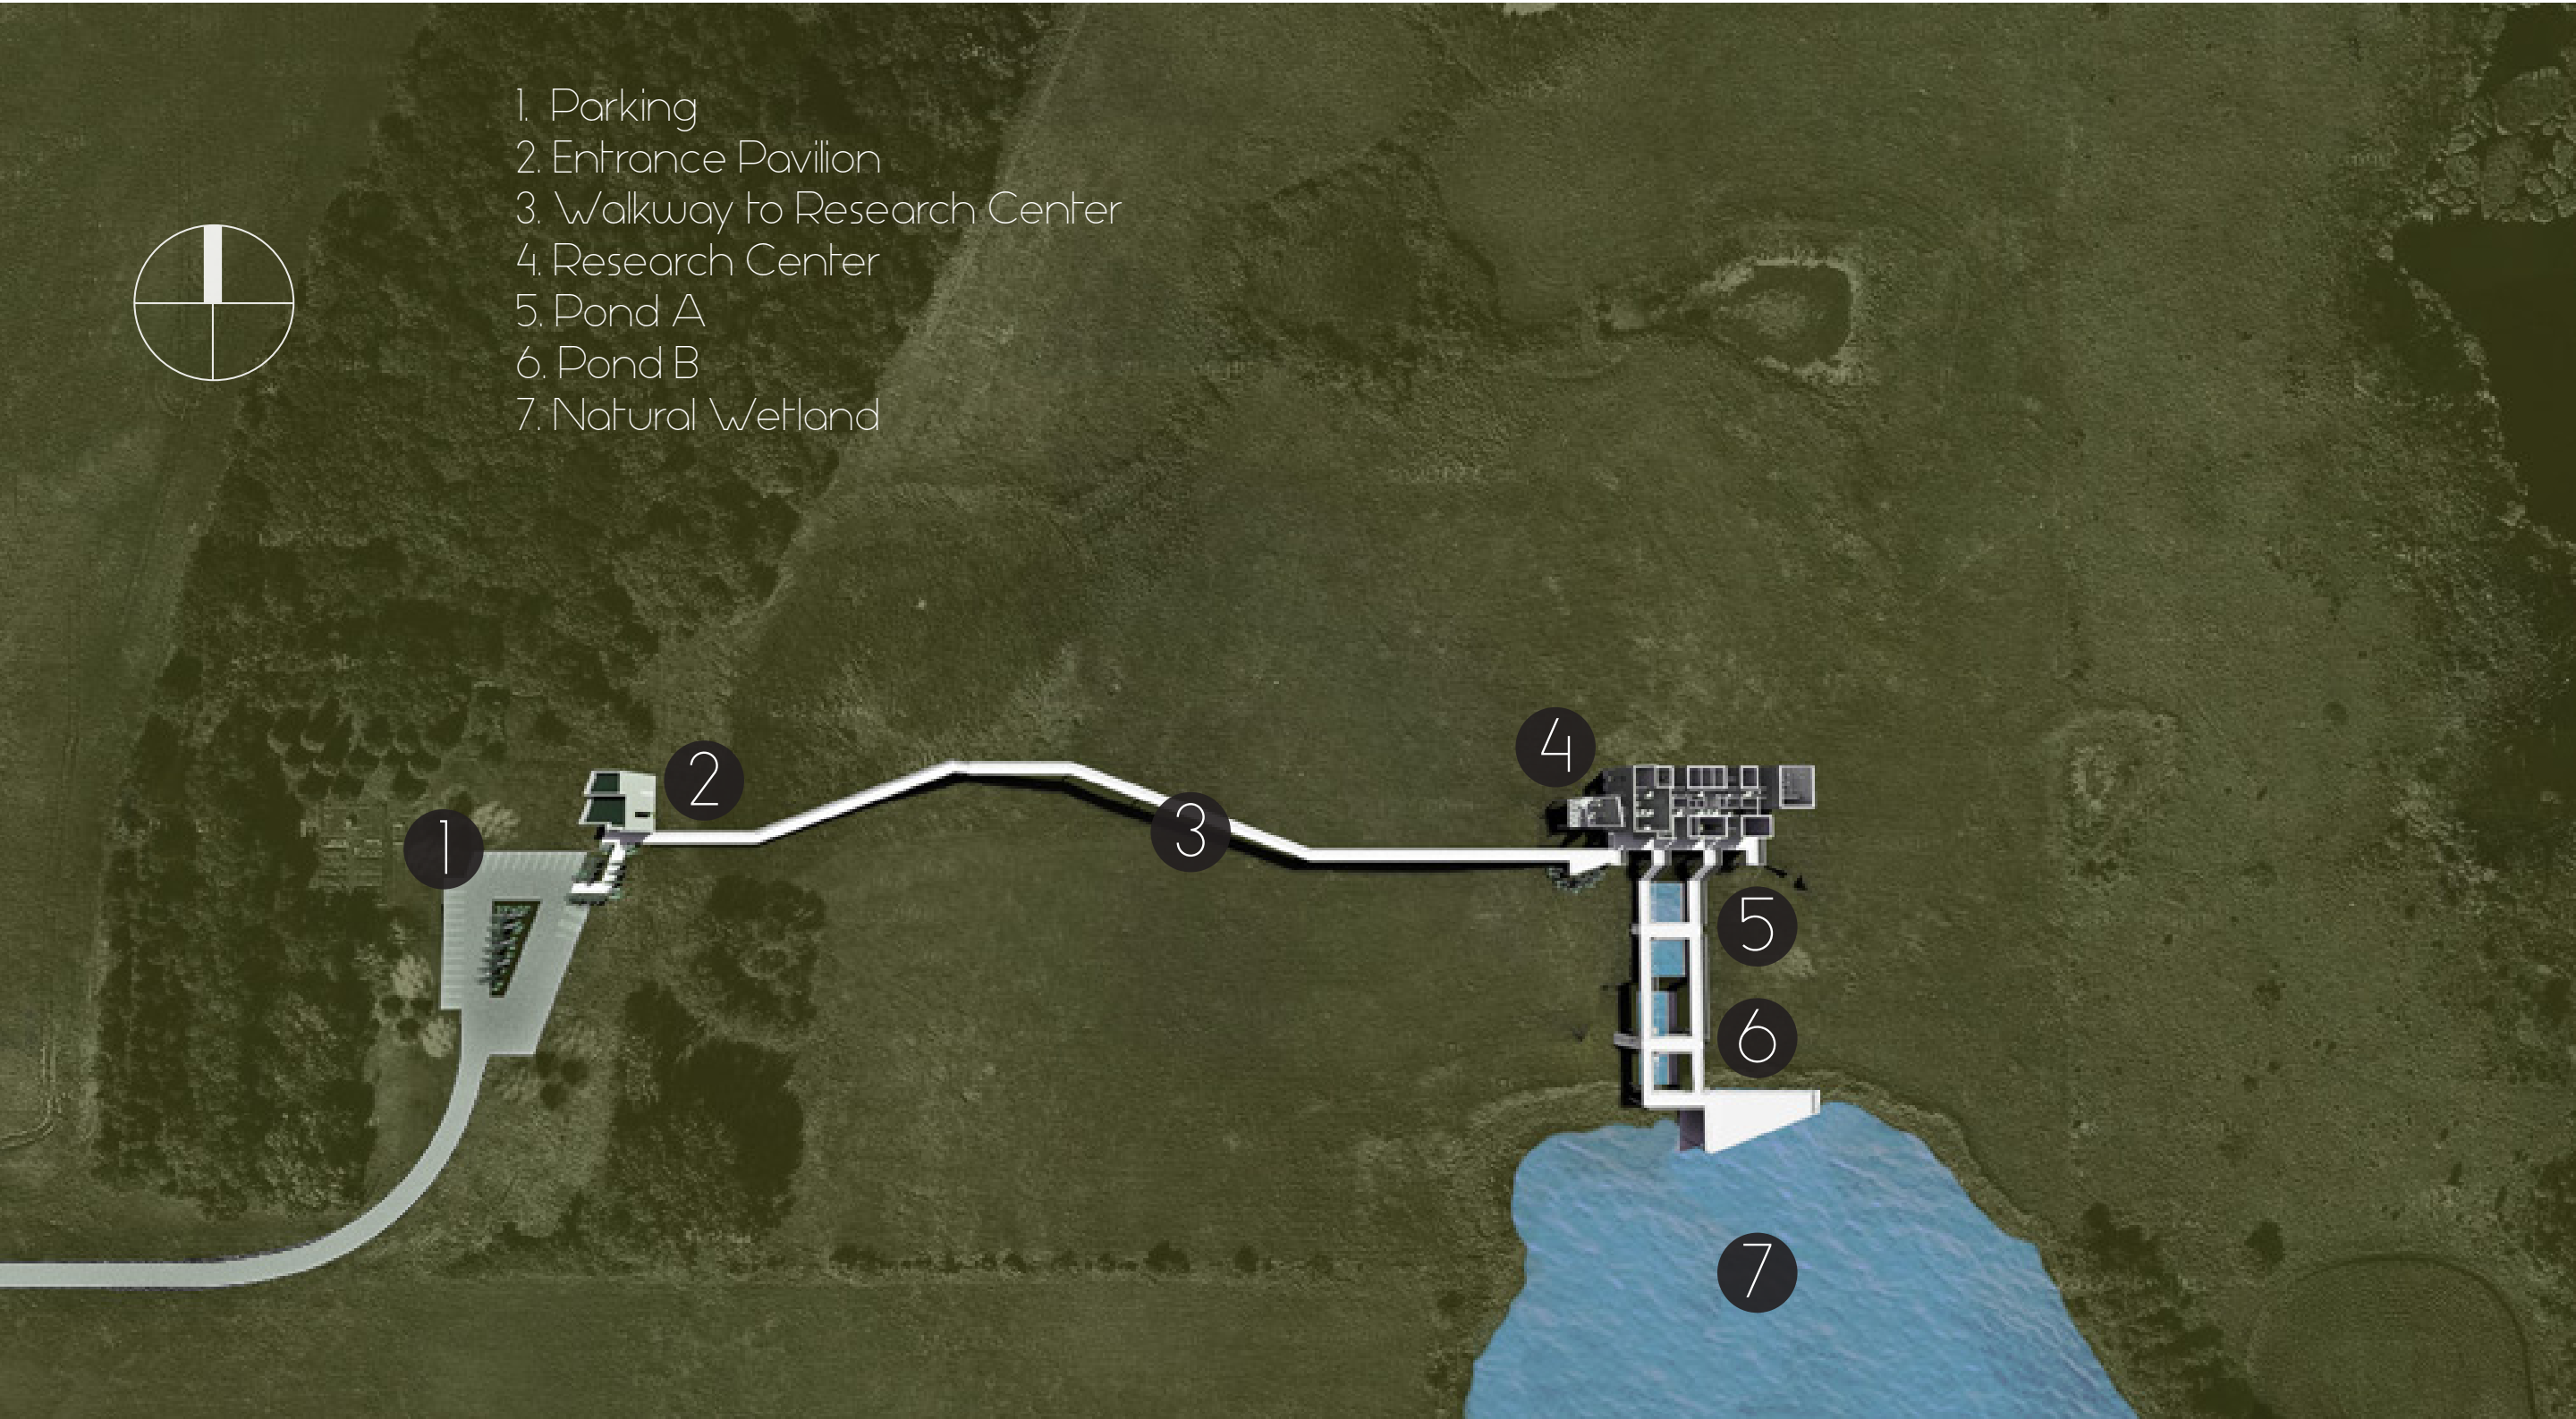
# Site Plan

1. Parking
2. Entrance Pavilion
3. Walkway to Research Center
4. Research Center
5. Pond A
6. Pond B
7. Natural Wetland

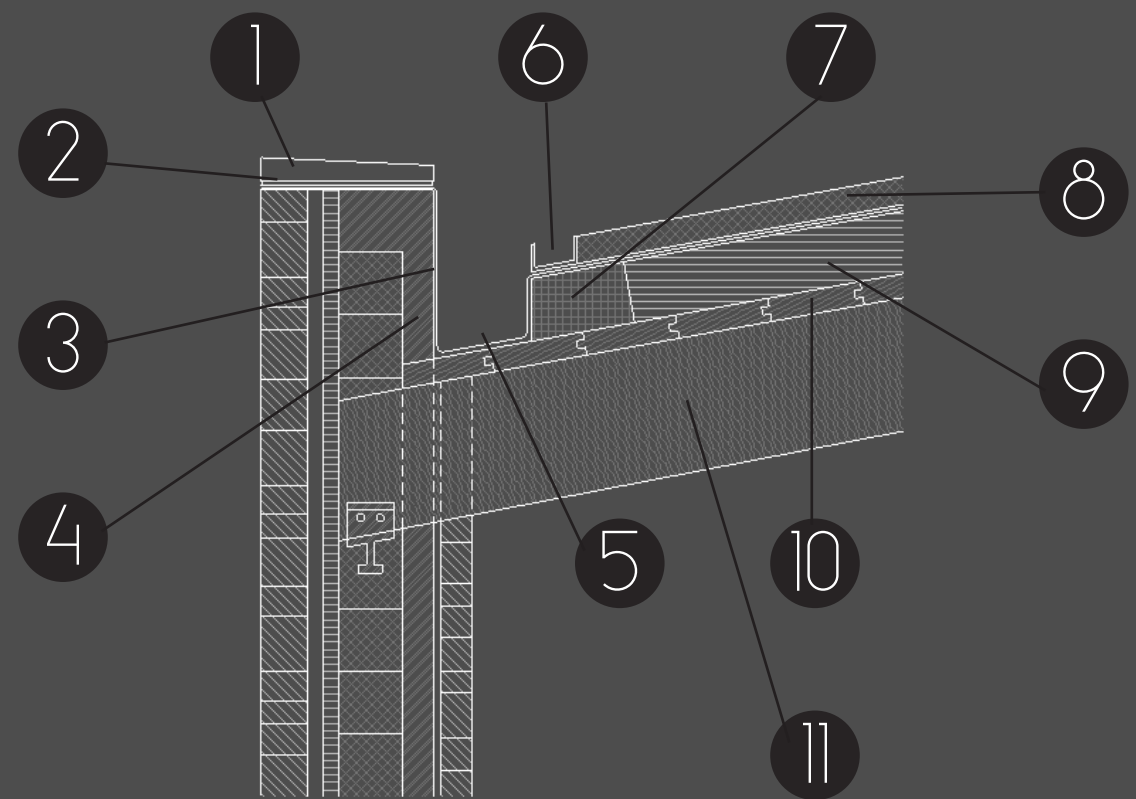
# Parapet Details

1. 3" Stone Cap
2. Flashing
3. EPDM Roof Membrane
4. Soy Based Foam Insulation
5. 1' 0" Gutter
6. 6" Gravel
7. Recycled Plastic Curb
8. 3 1/2" Growing Medium
9. 8" Rigid Insulation
10. 3" T&G Decking
11. 18" Glue Laminated Beam
