DEVELOPMENT OF AN ANTI-CORROSION THERMALLY SPRAYED COATING
SYSTEM FOR OIL AND GAS TRANSMISSION PIPELINE

A Dissertation
Submitted to the Graduate Faculty
of the
North Dakota State University
of Agriculture and Applied Science

In Partial Fulfillment of the Requirements
for the Degree of
DOCTOR OF PHILOSOPHY

Major Department:
Mechanical Engineering

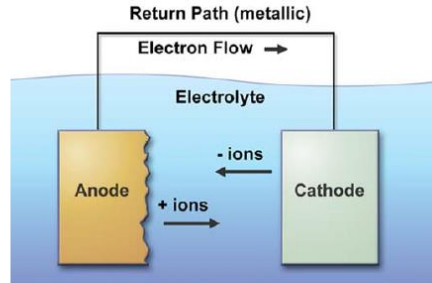
Figure 1.4. Schematic of a basic corrosion cell [4].

The simple schematic of the corrosion cell was shown in Figure 1.4.

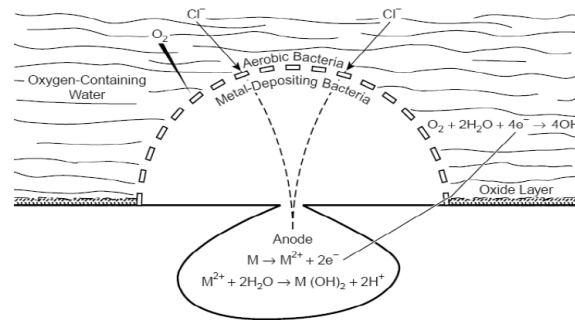
Figure 1.5. Possible reactions under tubercles created by metal deposition bacteria [5].

Mechanism of the MIC corrosion was illustrated in Figure 1.5.

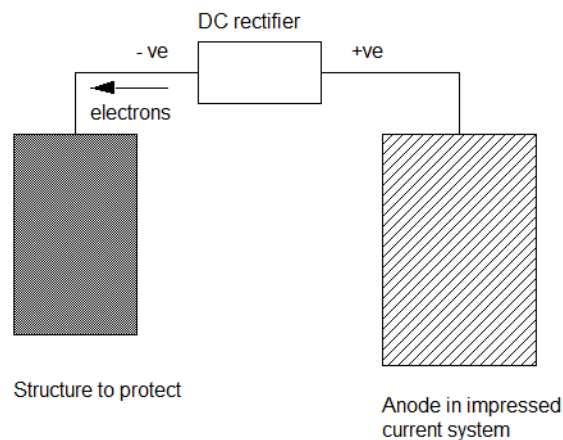
Figure 1.7. Schematic of impressed current system [8].

The objective of the inducing current is to ensure the component requiring protection maintained in its cathodic region by the application of a voltage or cathodic current. The schematic of this system is shown in Figure 1.7.

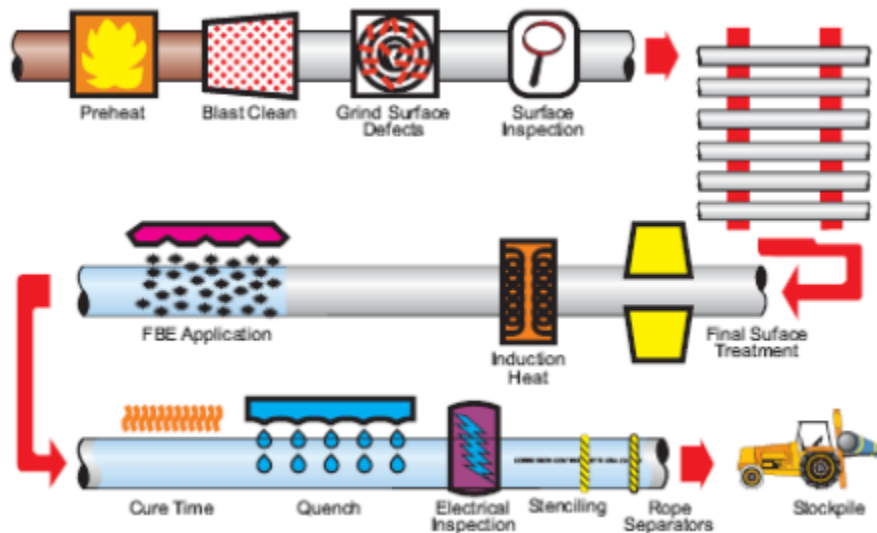
Figure 1.8. Schematic of Fusion Bonded Epoxy powder application process [9].

and utilized for protection of pipelines. These coatings possess good dielectric properties and degraded relatively slowly over time. However, the mechanical strength of these coatings was noticeably low such that rough handling would cause failure in the coating. Polyolefin coating was also introduced in this decade with acceptable adherent to the steel pipes. Two-layer and three-layer polyolefin coatings were also very commonly used outside of the United States. An epoxy-based coatings known as Fusion Bond Epoxy (FBE) which is also called “thin-film epoxy” is currently used to protect pipeline against corrosion. FBE is basically a thermoset polymer coating and its name originated from resin cross-linking and the method of application which is different from that of conventional liquid paint. The process of FBE coating is shown in Figure 1.8 schematically [10].

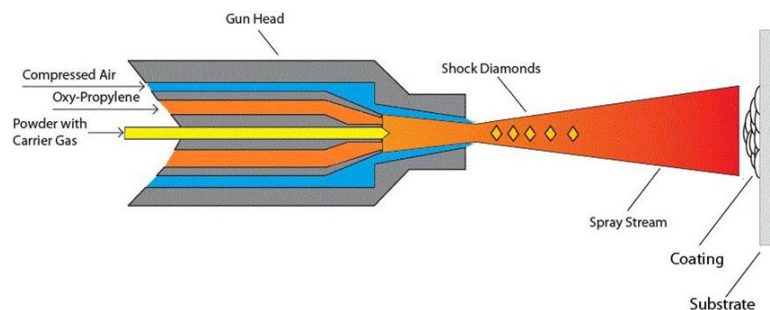
Figure 1.9. Schematic of HVOF spraying process [11].

HVOF is a process that utilizes supersonic acceleration of material up to several orders of magnitude above speed of sound. The schematic of HVOF process is demonstrated in Figure 1.9.

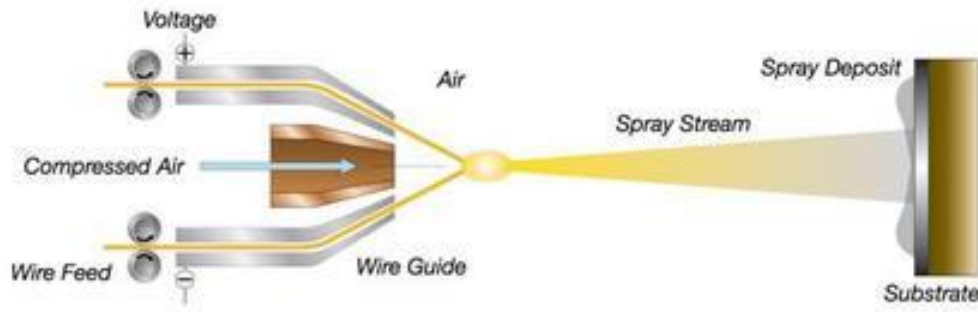
Figure 1.10. Schematic of wire arc spray technique [11].

Electric arc spray, which is known as twin-wire arc, arc spray, or wire arc spray has been commercially introduced to the market in early 1960s [4, 5]. Unlike the other thermal spraying techniques, in which feedstock particles are indirectly heated by hot gas jet, in electric arc spray process direct current (DC) is used to strike between two consumable electrode wires to effect direct melting. An electric arc is formed in the gap between the wire tips as the two wires are continuously fed together. There is a high velocity air jet located behind the intersection of the wires which shears away the molten particles and propels them toward the substrate. The velocity of in-flight particles in arc spray technique is ranged within 0.8-1.8 m/min which is much lower than that of HVOF. Figure 1.10 shows the schematic of the wire arc spray technique.

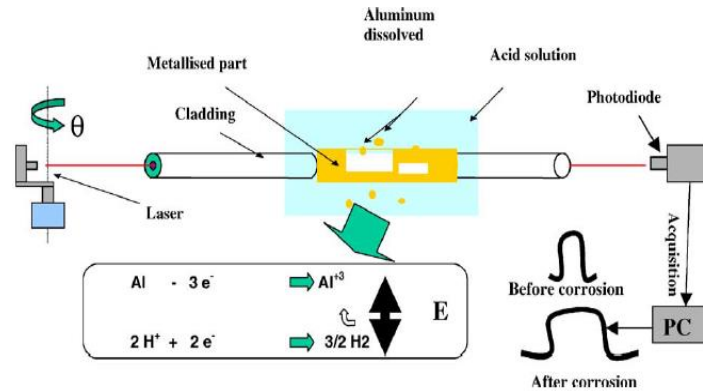
Figure 1.11. Principal of fuse-like corrosion sensor [22].

Optical sensors are based on transmission of light between a light source and a light detector. The transmission light can travel along either an air path or a fiber-optic cable. Either forms of transmission give immunity to electromagnetically induced noise and also provide greater safety than electrical sensors when used in hazardous environment [19]. In general, fiber-optic sensors, have long life, low cost, very good accuracy with $\pm 1\%$ of full scale reading, high reliability and small size [19]. The fiber section of fiber-optic cables can be made of plastic, glass, or combination of both materials. This type of sensor is proved to be able to detect pressure, displacement, pH, and smoke. Recently it has been several papers reported the succession of using fiber-optic as corrosion sensor [19, 21-24]. According to the study by S. A. Wade, et al [22], fiber optic corrosion can act as fuse-like sensor which two operating modes (on and off). In this study, they tried to address the proof-of-principle tests carried out on commercially available aluminum-coated optical fiber. The sensors were exposed in both non-corrosive environments (aqua region) and in sea water. The principal of using fiber-optic sensor as a fuse like sensor has been shown in Figure 1.11.

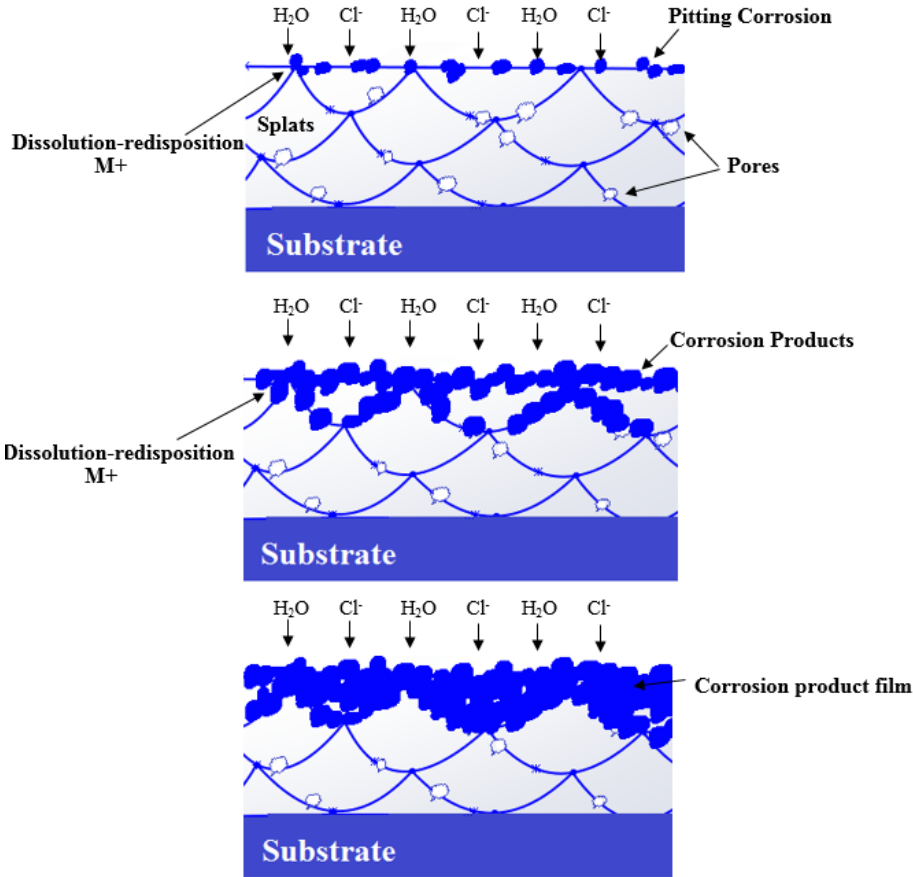
Figure 2.1. A Schematic of self-sealing mechanism of coating in NaCl solution, step by step process starting from top to the bottom.

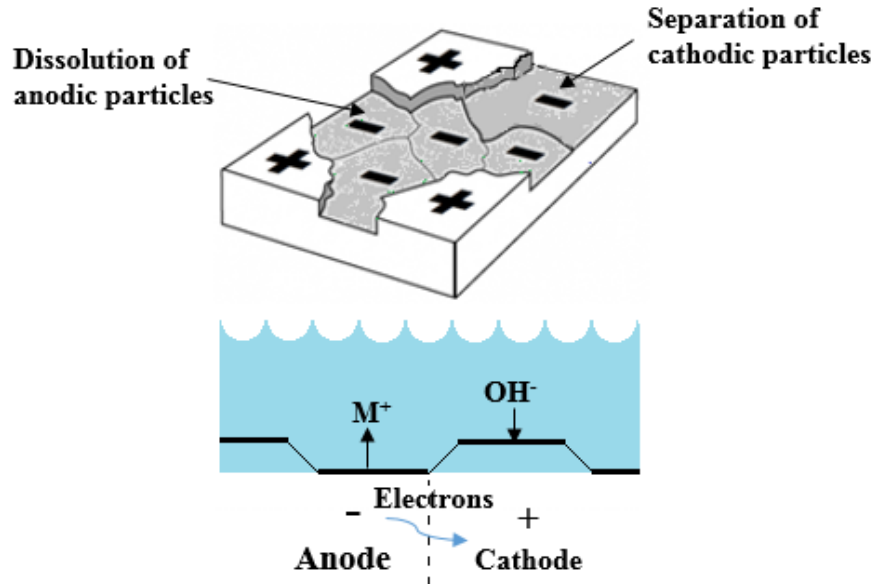
Figure 2.2. Schematic of micro-galvanic corrosion occurred in thermally sprayed coatings.

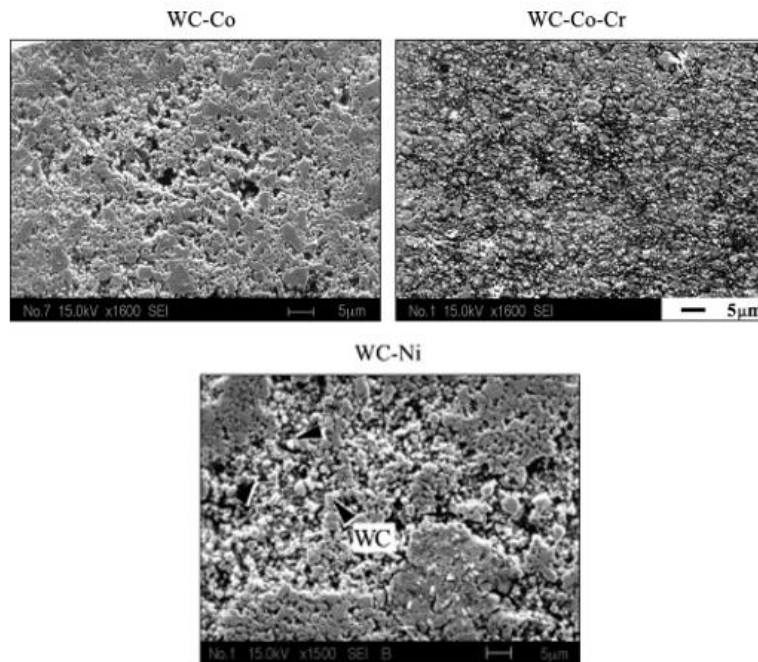
Figure 2.3. The representative SEM micrographs of HVOF deposited WC-based coatings after 120 h immersion in the aerated 5 wt.% H₂SO₄ solution [41].

The SEM micrographs of three WC-based HVOF deposited coatings with different binding materials have been shown in Figure 2.3. This figure has illustrated the effect of using various binders on the severity of micro-galvanic corrosion formation in tungsten carbide based coatings. The black regions on the micrographs has represented voids resulted from separation of WC particles from the surface. It can be concluded that WC-Co-Cr coating possessed the lowest level of micro-galvanic corrosion compared to the other coatings. For both WC-Co and WC-Ni coatings, a selective dissolution of the Co/Ni binder has first occurred in the HVOF deposited coating and led to separation of the WC particle [41]. Presence of Cr in HVOF deposited WC-Co-Cr coating has resulted in the formation of a stable chromium oxide passive layer, detected by XRD [41], which reduced the amount of Co dissolution and led to less separation of WC particle.

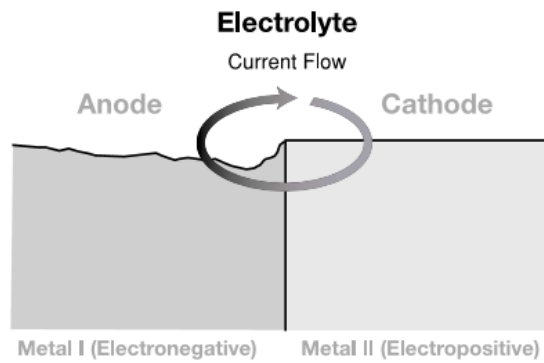
Figure 3.3. Bimetallic corrosion [3].

and a sustained cathodic reaction. In the case of bimetallic corrosion, the potential difference is created by the presence of dissimilar metals. Due to the dissimilar natural potentials, a current will flow from the anode (more electronegative) metal to the cathode (more electropositive) which will increase the corrosion on the anode. Since the materials of coating and the pipe could have dissimilar electronegativity, likelihood of the bimetallic corrosion should be considered during materials selection process. The schematic of the bimetallic corrosion is shown in 4.3 [3].

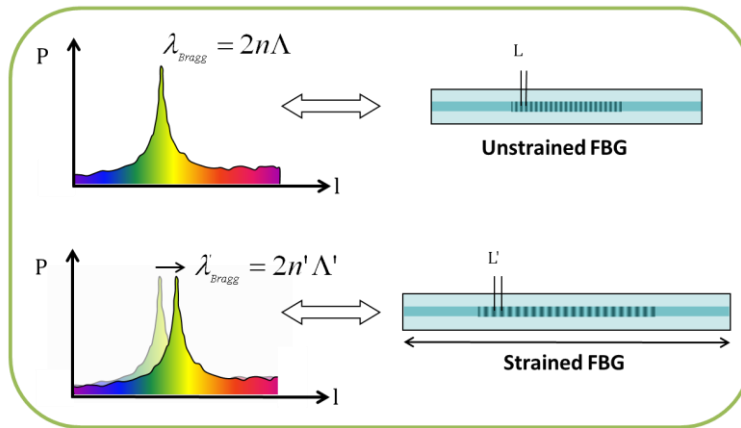
Figure 4.1. Illustrative structure of an FBG spectrum under strain.

To enable the self-sensing capability of the thermally sprayed coatings on steel pipes for corrosion assessment, Fiber Bragg Grating (FBG) sensors embedded inside the coating was developed. The FBG based corrosion sensor shown in Figure 4.1 operated by monitoring the corrosion induced visual property change of the coated iron-particle thin film. The effective refractive index of the fiber cladding and the thickness of the coated thin film changed when the coated iron particles were corroded. As a result, the resonant wavelength of the FBG changed correspondingly. Therefore, monitoring of the change in the resonant wavelength of the FBG sensor provided key information about the mass loss and the material property change of the iron particles over time in a corrosive environment.

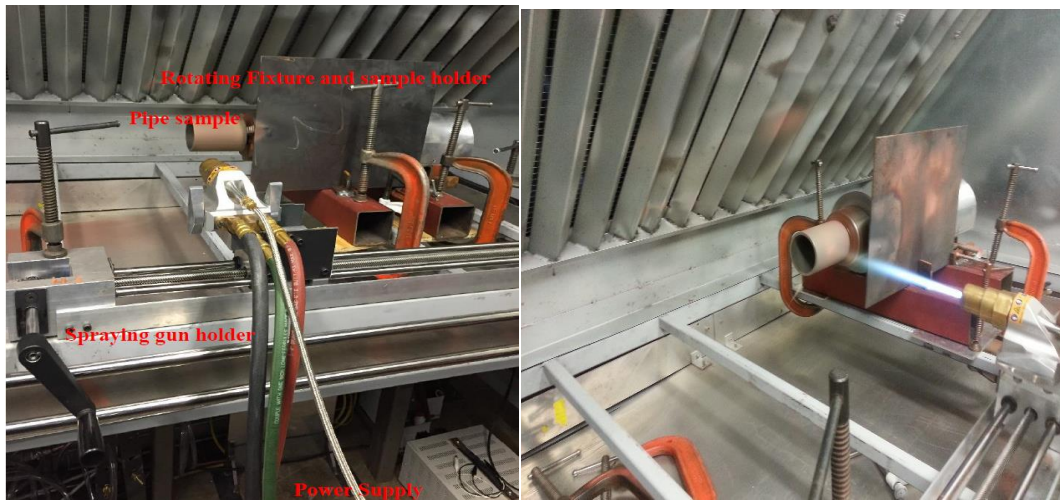
Figure 4.2. (a) Setup for automatic rotational fixture for HVOF spraying and (b) spraying process.

connected to a speed-controlled power supply, and a screw driver custom made movable spraying gun holder. Pipes with inner diameter from 1 inch to 12 inches were placed on the holder for coating deposition. The pipe could be rotated at various speeds from low to high during the spraying process to meet the requirement for different spraying thickness. The spraying gun holder could move horizontally at constant speed to provide a uniform deposition on the surface of the pipe samples. The spraying setup containing the pipe and gun holder were shown in Figure 4.2 (a) while spraying process was illustrated in Figure 4.2 (b).

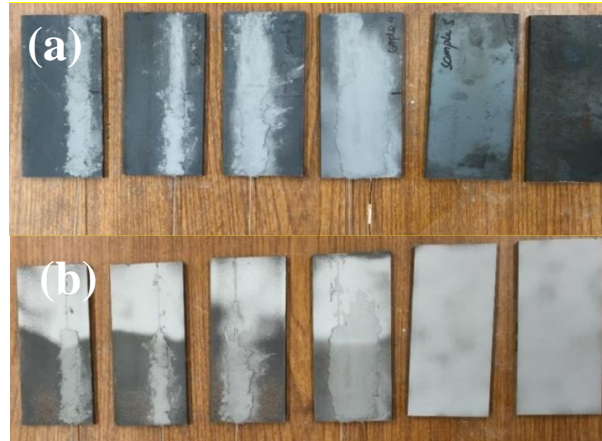
Figure 4.4. Prepared samples (a) after sensor embodiments and (b) after sand blasting.

To ensure a successful protection of the fiber optic strain sensors during the HVOF thermal spraying coating process, two different sizes of hypodermic tubes had been used. A smaller-diameter hypodermic tube was applied to protect the sensing unit with 0.006 in. of inner diameter and 0.010 in. of outer diameter. A slightly larger diameter hypodermic tube was applied to protect the communication optical fibers from the high velocity of HVOF thermal spraying process with an inner diameter of 0.028 in. and an outer diameter of 0.0425 in. For fiber optic temperature sensor, since a relative thicker steel tube was applied by manufacturers for sensor protection, no future protection was taken. After the documentations of the sensor locations, the sensors were embedded using stainless-steel-based metallic adhesive (Durabond 954). Figure 4.3 (a) has shown all the prepared samples for HVOF thermal spraying coating and Figure 4.4 (b) shown the samples after sand blasting process. As it can be seen from Figure 3.9. (b), only the top half of the samples where the sensors located will be thermal sprayed.

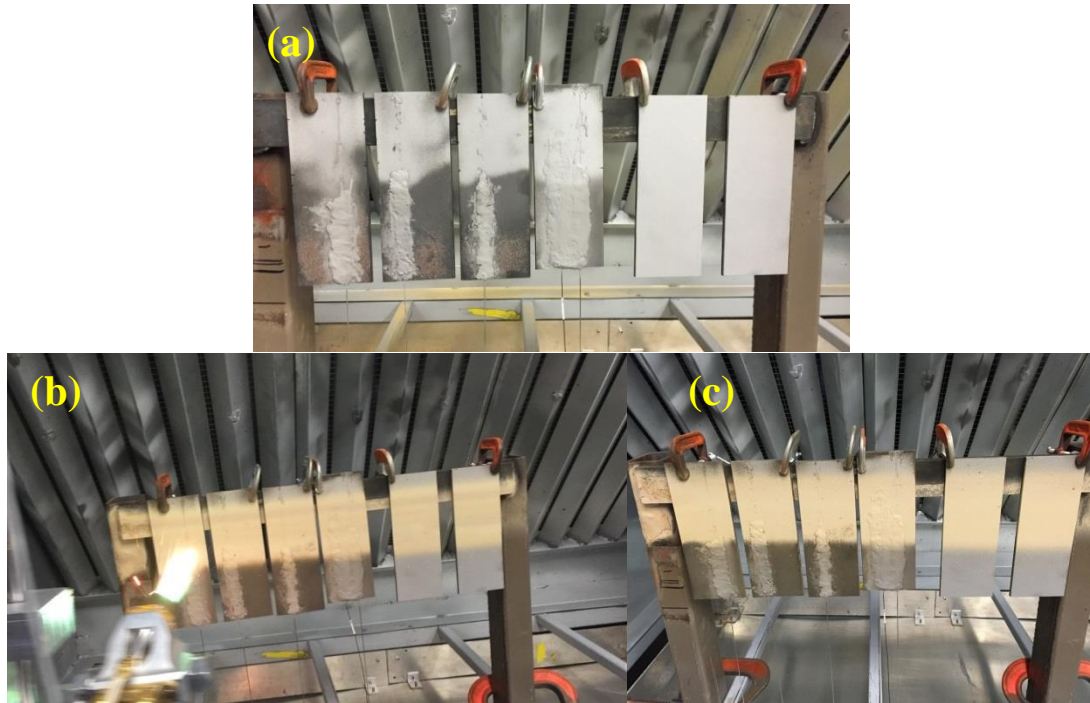
Figure 4.5. (a) Sample setup, (b) thermal spraying process (c), and samples after successful thermal spraying.

The prepared samples were then thermal sprayed by the selected materials selected for elevated temperature applications: WC-based, Nickel-based including, and room temperature applications: pure copper, Al-Zn, and Al-bronze alloys (Figure 4.4). HVOF technique with automatic robotic spraying arms in mechanical department at NDSU has been used to develop Ni-base, WC-base, and copper coatings. Al-Zn coating has been generated by wire-arc spray technique. The elemental compositions of the powder used were shown in Figure 4.3.

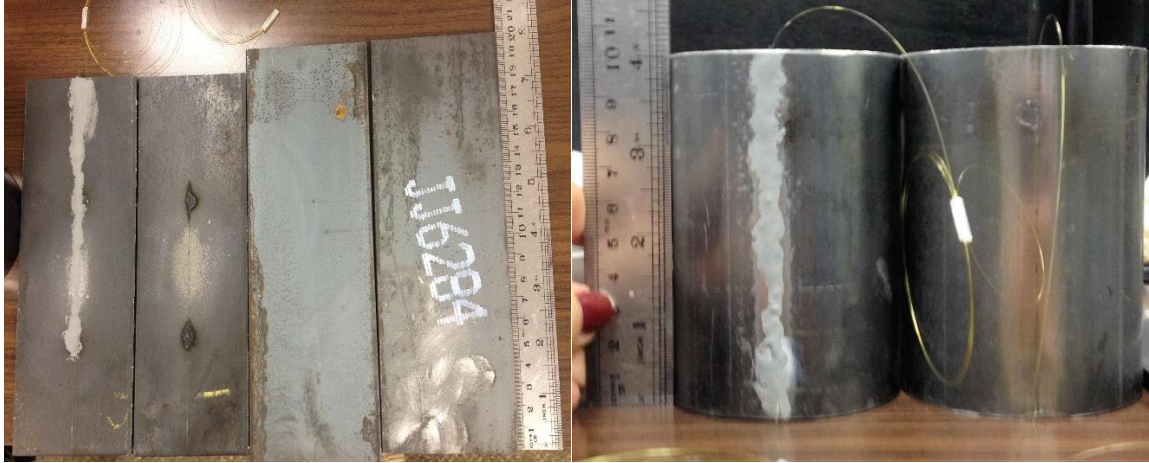
Figure 4.6. Schematic of sample preparation for arc spray coating.

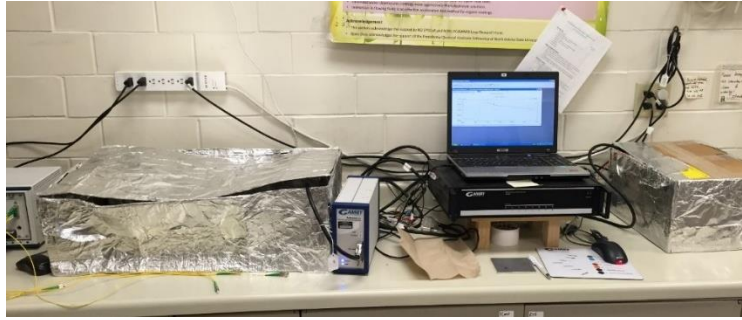
Figure 4.7. Electrochemical Accelerated Corrosion Tests Equipment Set-up.

Potentiodynamic Polarization Technique. The accelerated corrosion tests were performed by placing the coated and uncoated steel samples in 3.5% NaCl solutions. A Gamry Reference 600 Potentiostat-Galvanostat-ZRA instrument as shown in Figure 4.7 was used to analyze the corrosion performance.

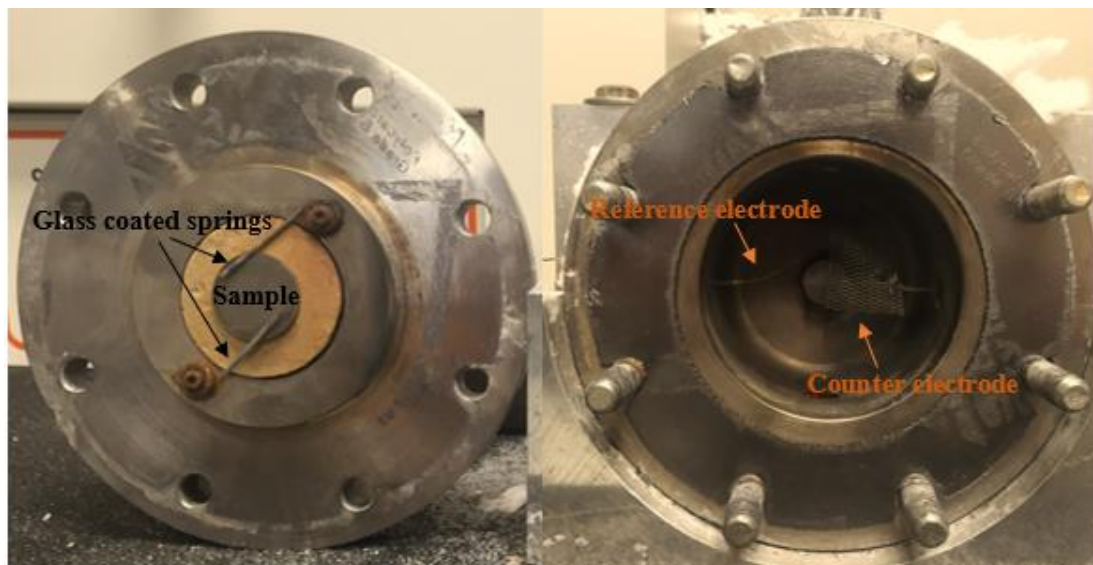
Figure 4.9. Sample and electrode placement inside the pressure vessel.

As shown in Figure 4.9, the device consists of five main parts including: (1) pump assembly, (2) heater, (3) pressure gauge, (4) heat exchanger, and (5) pressure vessel assembly. Inconel 718 and WC-Ni coated steel with exposed area of $1.6 \times 1.9 \text{ cm}^2$ was used as the working electrode. The sample was embedded in the pressure vessel as illustrated in Figure 4.9.

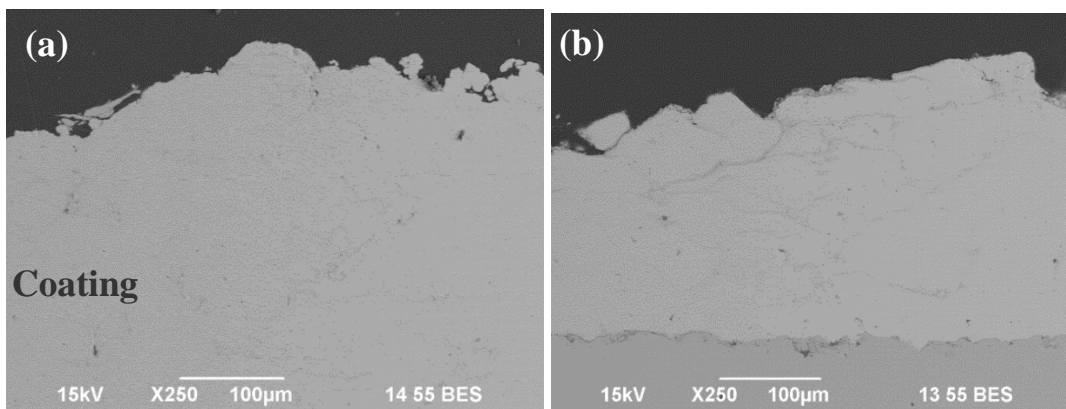
Figure 5.1. SEM images of (a) HVOF deposited copper coating before corrosion and (b) after corrosion.

The micrograph of HVOF deposited copper coating were shown in Figure 5.1 The coating thickness was approximately 800 μ m. Image analysis showed existence of only 3% porosity within the microstructure, indicating a dense coating. In addition, a good cohesion between copper splats was indicated from the microstructure.

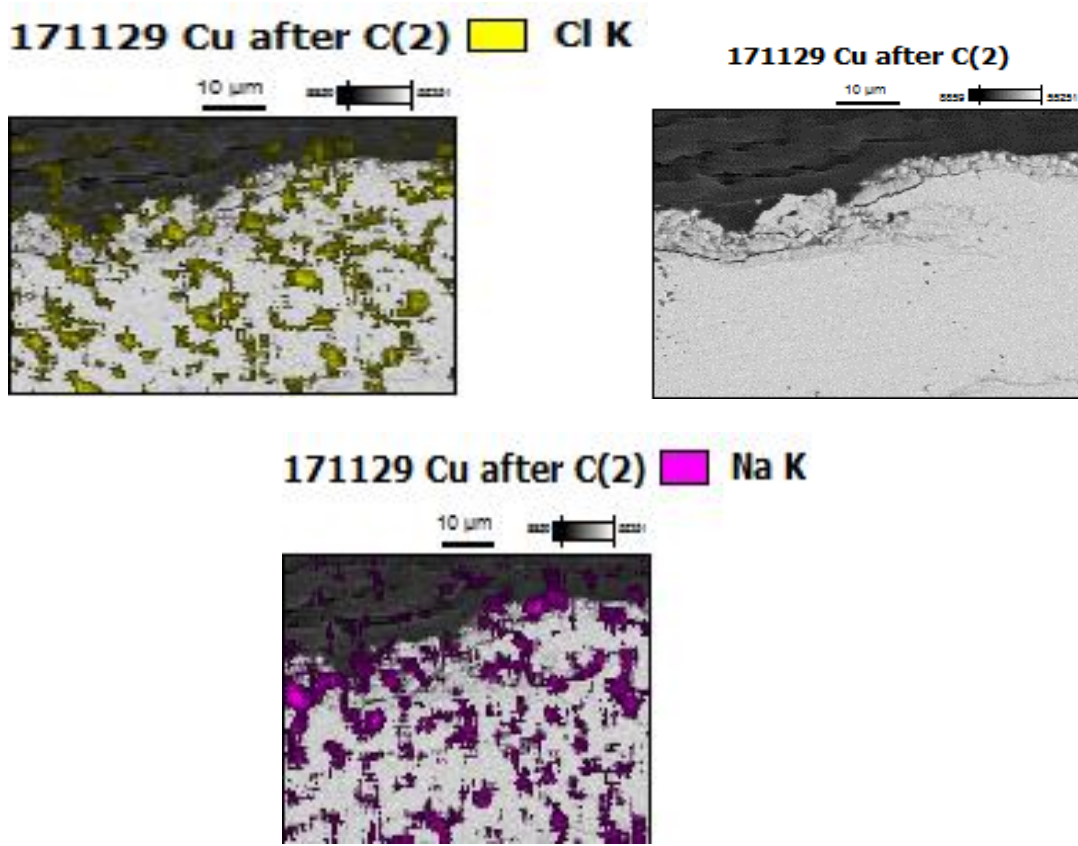
Figure 5.2. EDS maps of Cl⁻, and Na elements penetrated in the HVOF sprayed copper coatings after corrosion experiment.

As the EDS result demonstrates, chlorine and sodium could considerably diffuse in the copper coating for less than depth of 50μm. XRD-pattern of the HVOF sprayed copper coatings also exhibited some dissimilarity when before and after corrosion conditions compared. The XRD pattern shown in Figure 5.3 demonstrated that copper oxide was the main composition appeared after corrosion whilst it was not detected in the coating structure before the corrosion experiments.

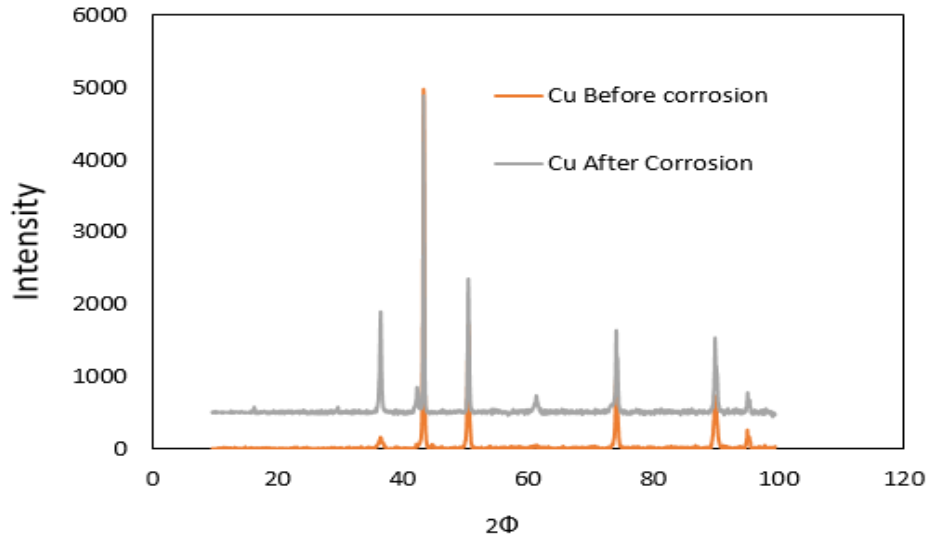
Figure 5.3. X-Ray pattern of HVOF sprayed Copper coatings before and after corrosion.

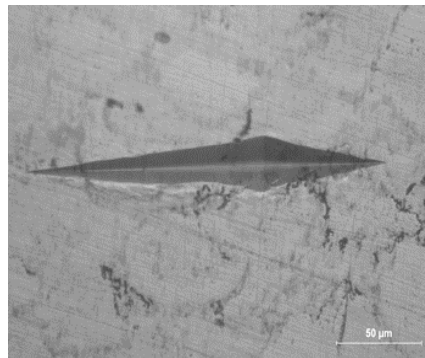
Figure 5.4. Knoop indentation on HVOF deposited Copper.

To further investigate the influence of the porosity on mechanical property of the thermally sprayed Cu coating, the hardness indentation has been examined and presented in Figure 5.3. The average hardness of the Cu coating is 96.5 HK ($\approx 83\text{Hv}$).

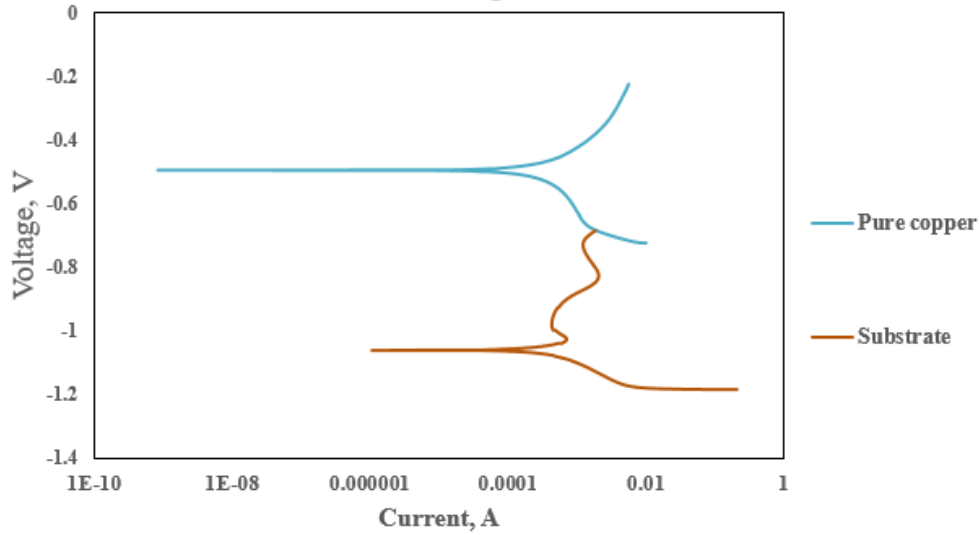
Figure 5.5. Tafel curves of copper coated and uncoated steel samples in 3.5% NaCl solution.

Corrosion behavior of the HVOF deposited copper coating was investigated using polarization technique in 3.5% NaCl solution. The Tafel curve and some important corrosion parameters extracted from this experiment has been reported in Figure 5.5, and, respectively. As the data summarized in Figure 5.4 advocated, copper coating deposited by HVOF resulted in higher corrosion resistance of the surface.

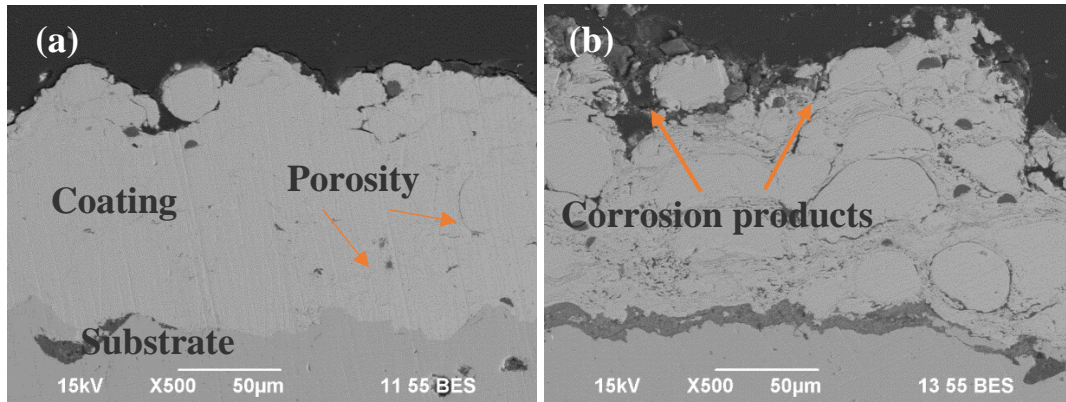
Figure 5.6. SEM images from (a) HVOF deposited Cu-Al-Bronze coating before and (b) after corrosion.

Figure 5.6 (a) has shown the SEM image of the HVOF deposited Cu-Al Bronze coating before and after being subjected to the corrosion reaction. The Diamalloy1004 powder was used as the coating materials which is golden-colored and produced using gas atomization technique in inert gas environment. Aluminum and Iron are considered as major alloying elements to be used in Cu-Al-Bronze alloy.

By comparison the SEM micrograph before and after corrosion, as demonstrated in Figure 5.6 (a, b), it could be concluded that corrosion products significantly were formed on the surface of the HVOF deposited Al-bronze coating due to its reaction with the corrosive solution. The dark gray areas presented very close to the surface of the coating were observed after corrosion which did not exist in the SEM micrograph of the HVOF deposited Al-bronze before corrosion test.

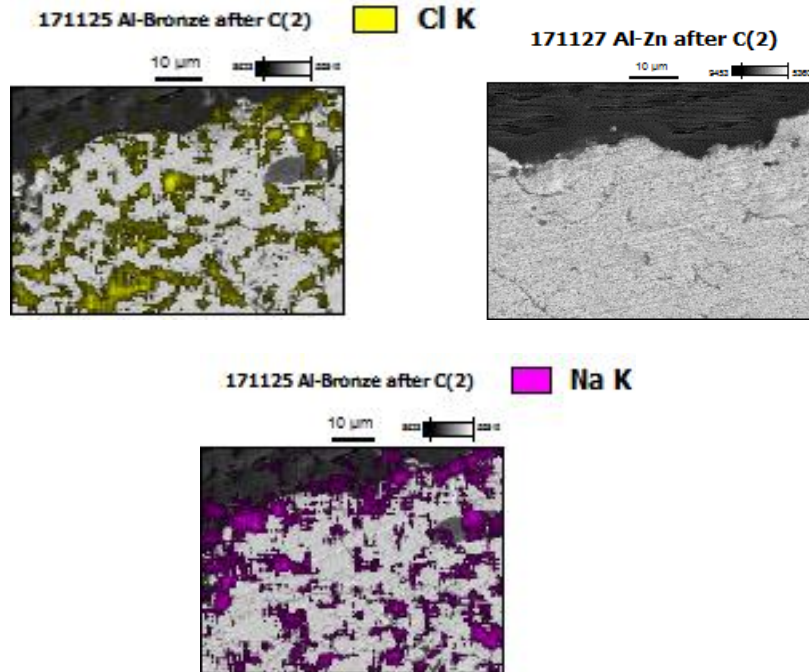
Figure 5.7. EDS maps of Cl⁻ and Na elements penetrated in the HVOF thermal sprayed deposited coatings after corrosion experiment.

The colored area shown on Figure 5.8 representing for Cl⁻ and Na elements diffused into the surface. According to the EDS map shown in Figure 5.7, Al-bronze acted less effective compared to the other coatings studied in this thesis in terms of blocking the sodium elements inside the coating.

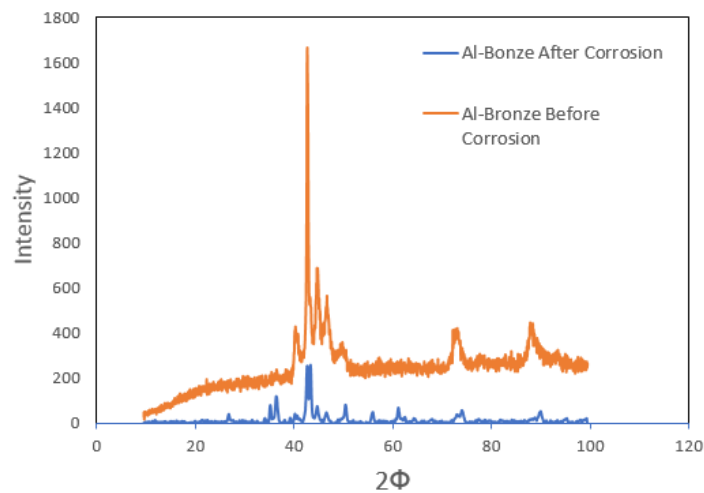
Figure 5.8. X-Ray pattern of HVOF sprayed Al-bronze coatings before and after corrosion.

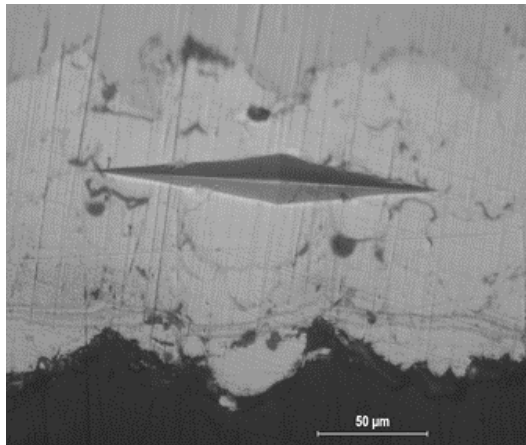
Figure 5.9. Knoop indentation on HVOF deposited Cu-Al-Bronze.

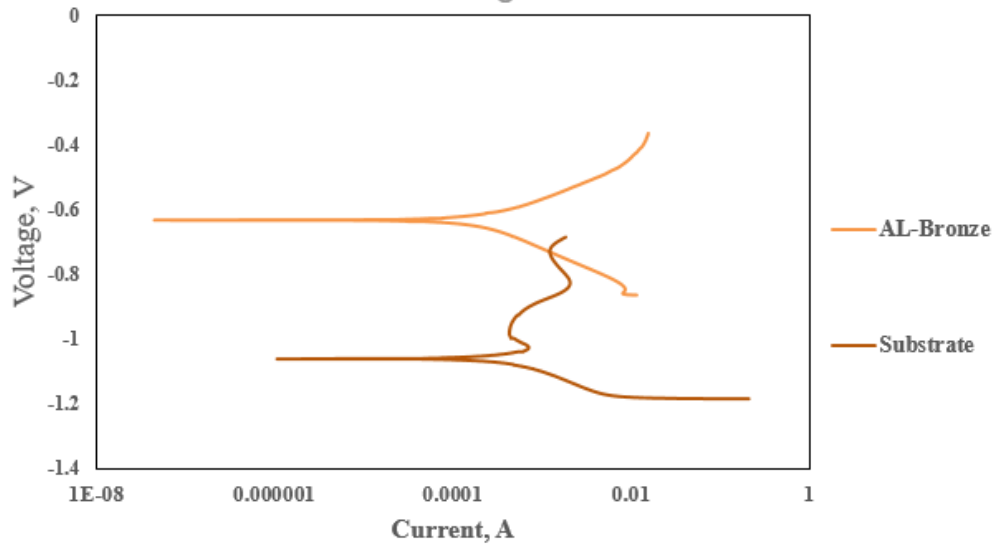
Figure 5.10. Tafel curves of Cu-Al-Bronze coated and uncoated steel samples in 3.5% NaCl.

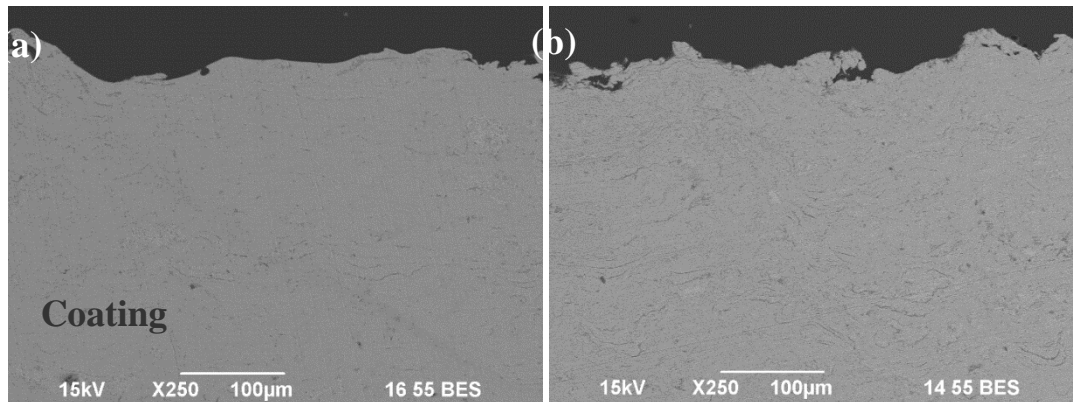
Figure 5.11. SEM micrographs of (a) Wire arc deposited Al-Zn coating before and (b) after corrosion.

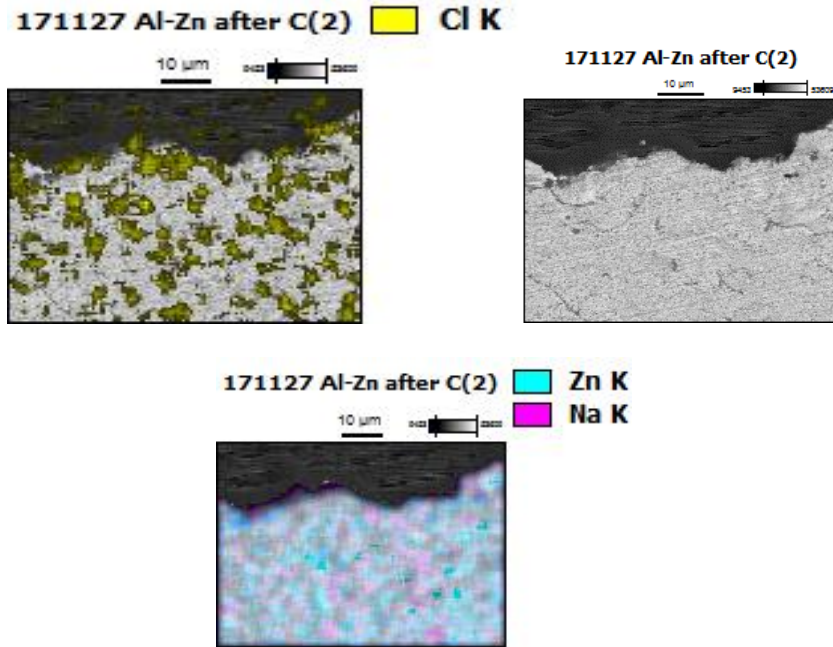
Figure 5.12. EDS maps of Cl⁻ and Na⁺ elements penetrated in the wire-arc deposited Al-Zn coatings.

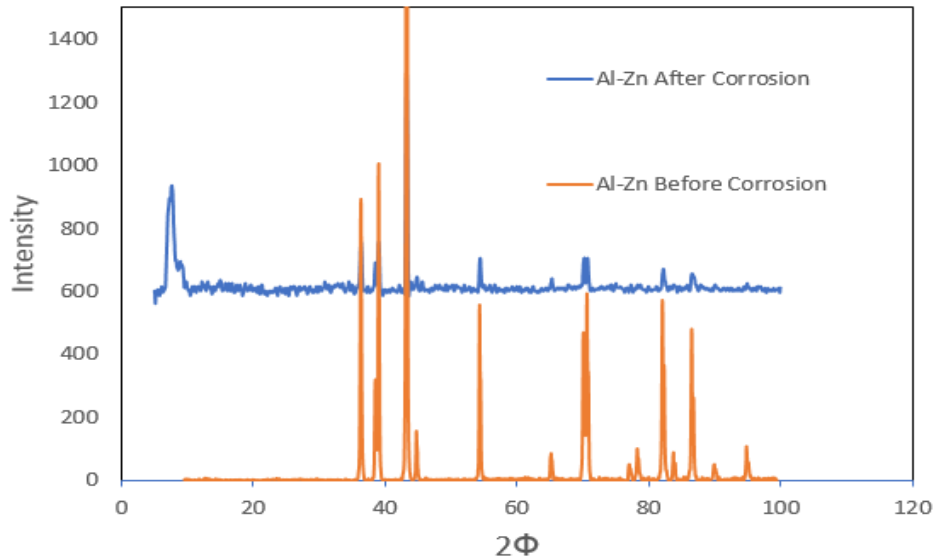
Figure 5.13. X-Ray pattern of wire-arc sprayed Al-Zn coatings before and after corrosion.

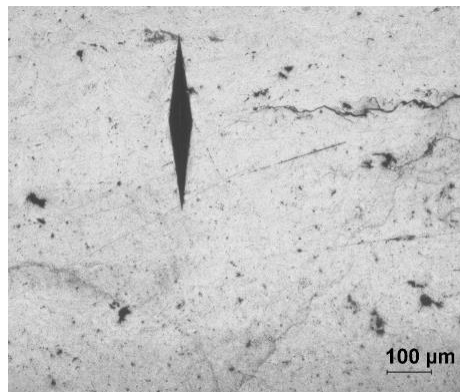
Figure 5.14. Knoop indentation carried out on wire arc sprayed Al-Zn coating.

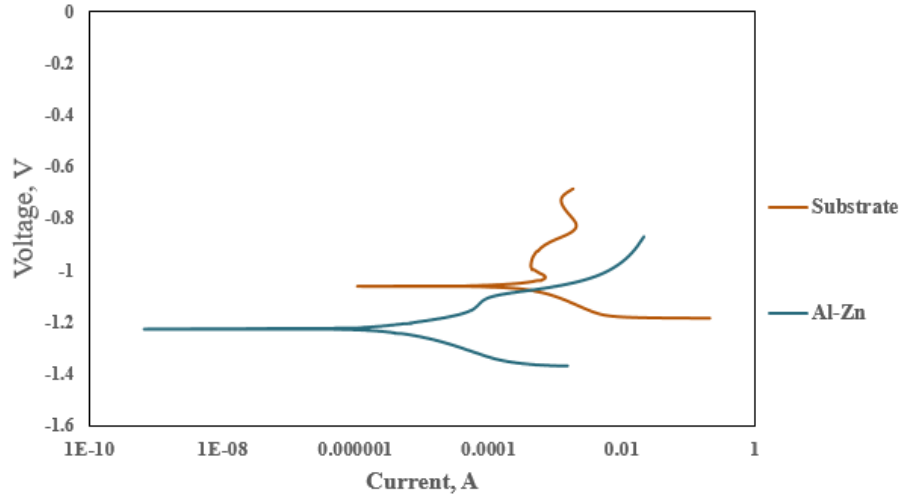
Figure 5.15. Tafel curves of Al-Zn coated and uncoated steel samples in 3.5% NaCl.

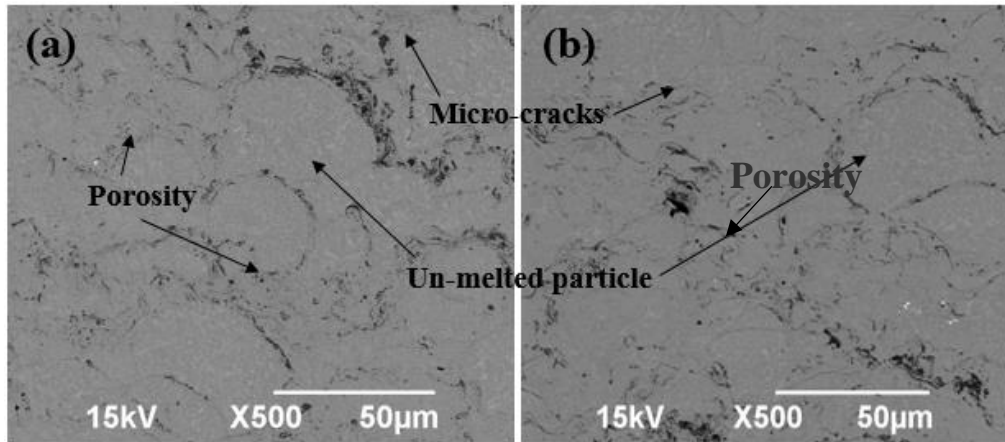
Figure 5.16. SEM micrographs of (a) Inconel 718/Inconel 718 and (b) Inconel 718/Steel coating cross-sections.

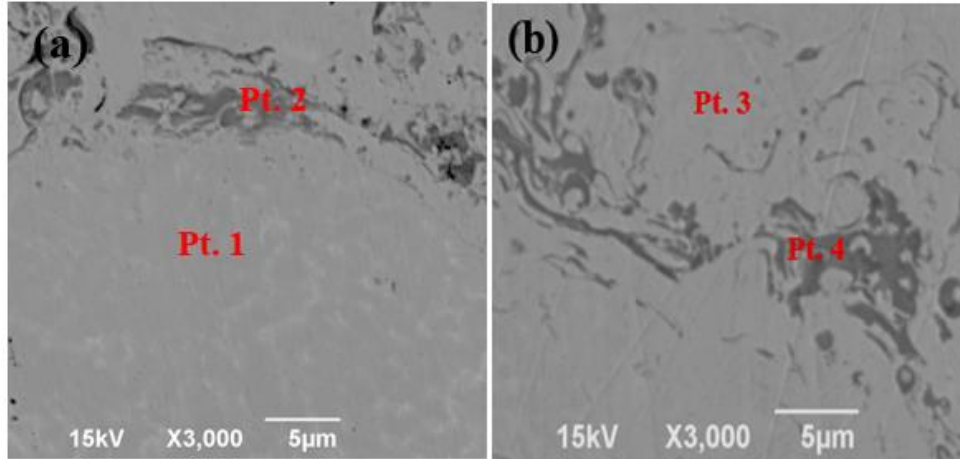
Figure 5.17. High magnification SEM micrographs of (a) Inconel 718/Inconel 718 and (b) Inconel 718/Steel.

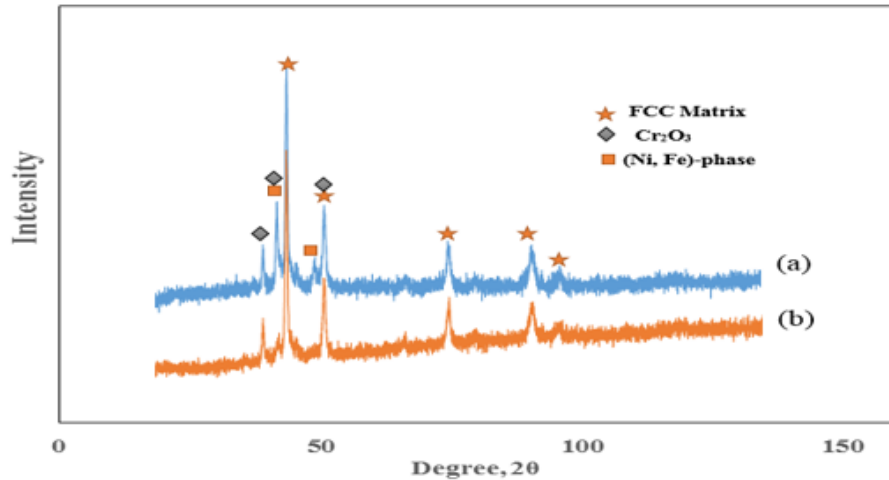
Figure 5.18. XRD results of the Inconel 718 coatings deposited on (a) Inconel 718 and (b) Steel substrates.

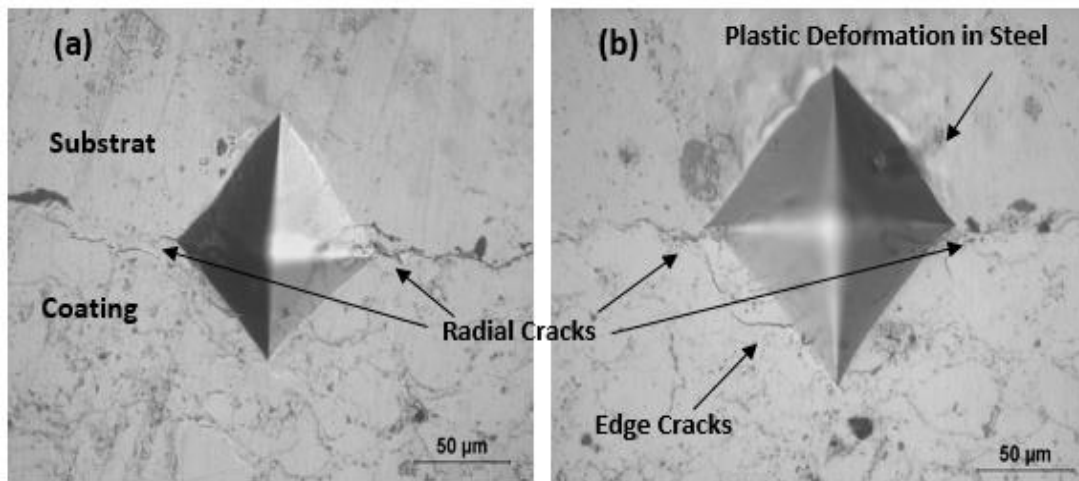
Figure 5.19. Vickers indentation on the interfaces of (a) Inconel 718/Inconel 718 and (b) Inconel 718/Steel samples.

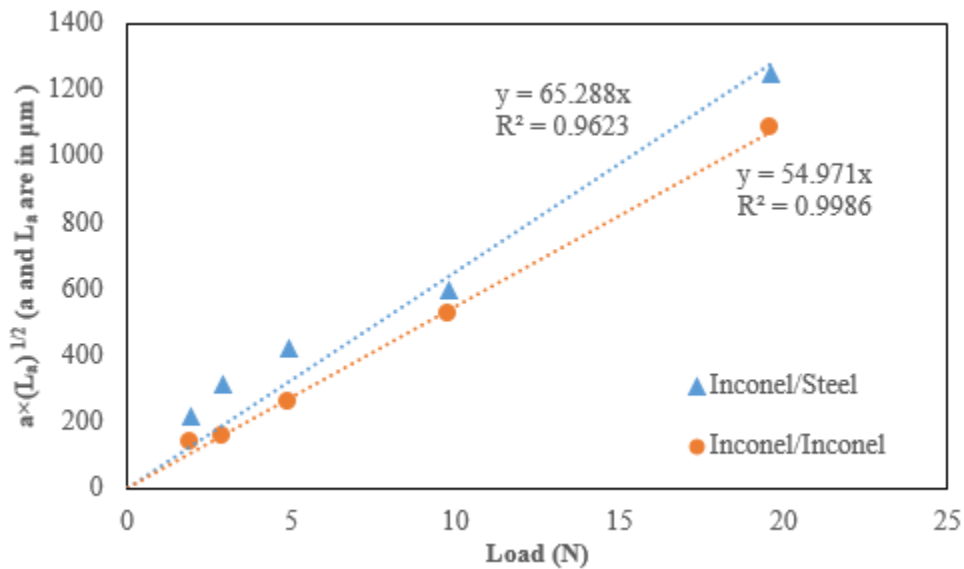
Figure 5.20. Fracture toughness assessment based on crack length indication.

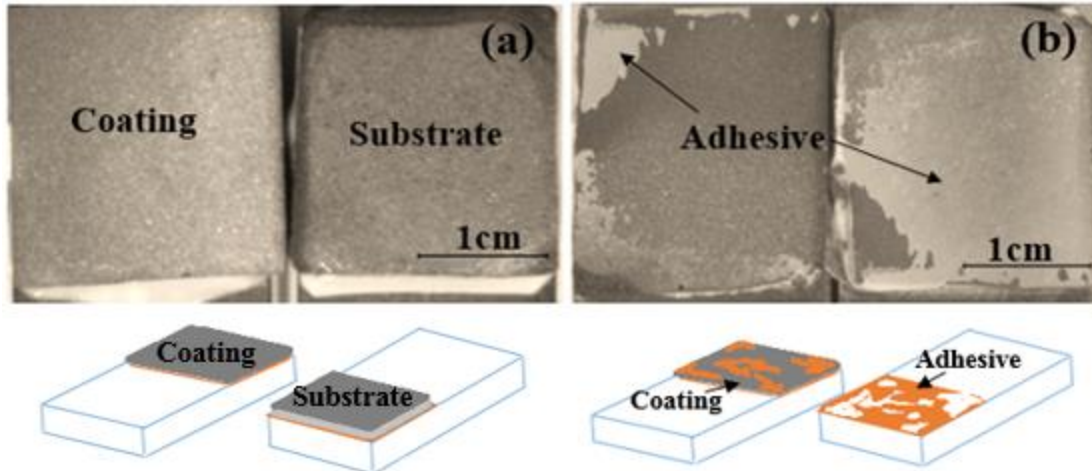
Figure 5.23. Macroscopic and schematic of the interfaces and failure modes in (a) Inconel 718 coating-Steel substrate and (b) free-standing Inconel 718 coating.

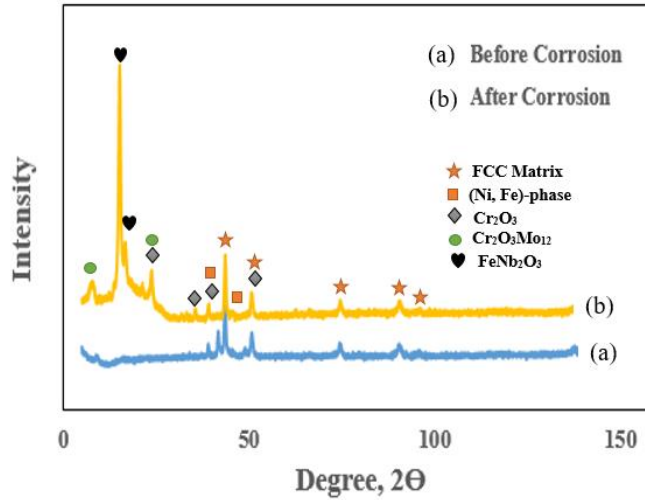
Figure 5.24. XRD patterns for the HVOF Inconel 718 coatings (a) before and (b) after corrosion.

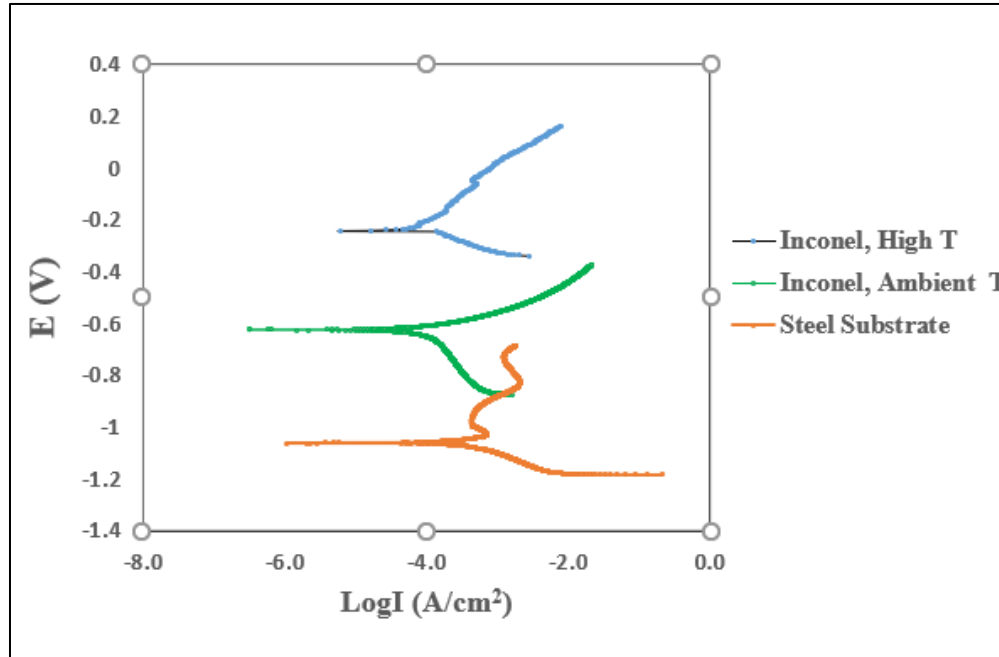
Figure 5.25. (a) Polarization curves of Inconel 718 coating at 250°C and ambient temperature and carbon steel substrate at ambient temperature in 3.5wt% NaCl solution.

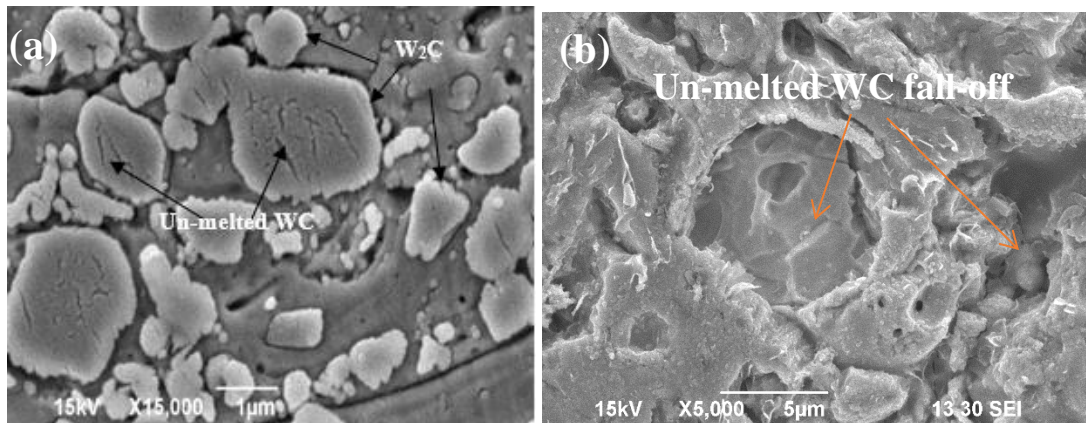
Figure 5.26. SEM micrographs of WC-Ni coatings (a) before and (b) after corrosion.
