DEVELOPMENT OF AN ANTI-CORROSION THERMALLY SPRAYED COATING
SYSTEM FOR OIL AND GAS TRANSMISSION PIPELINE

A Dissertation
Submitted to the Graduate Faculty
of the
North Dakota State University
of Agriculture and Applied Science

In Partial Fulfillment of the Requirements
for the Degree of
DOCTOR OF PHILOSOPHY

Major Department:
Mechanical Engineering

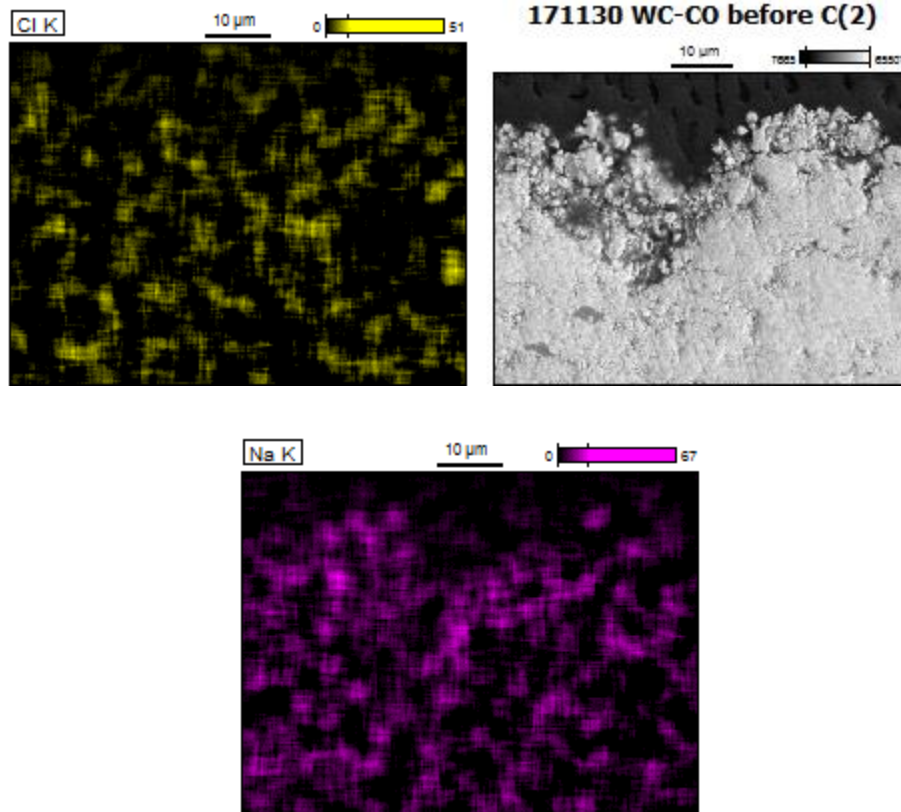
Figure 5.27. EDS maps of Cl^- and Na^+ elements penetrated in the HVOF deposited WC coatings.

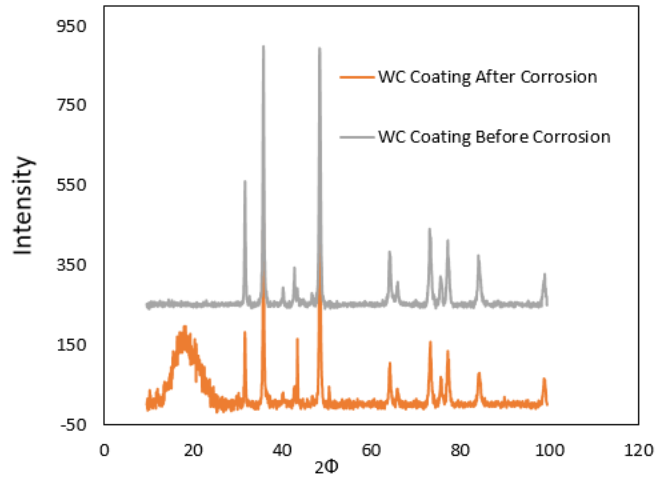
Figure 5.28. XRD pattern of WC coating before and after corrosion test.

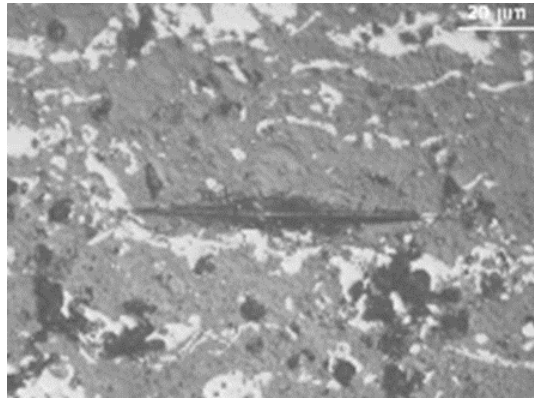
Figure 5.29. Knoop hardness indentation on HVOF deposited WC-Ni coating.

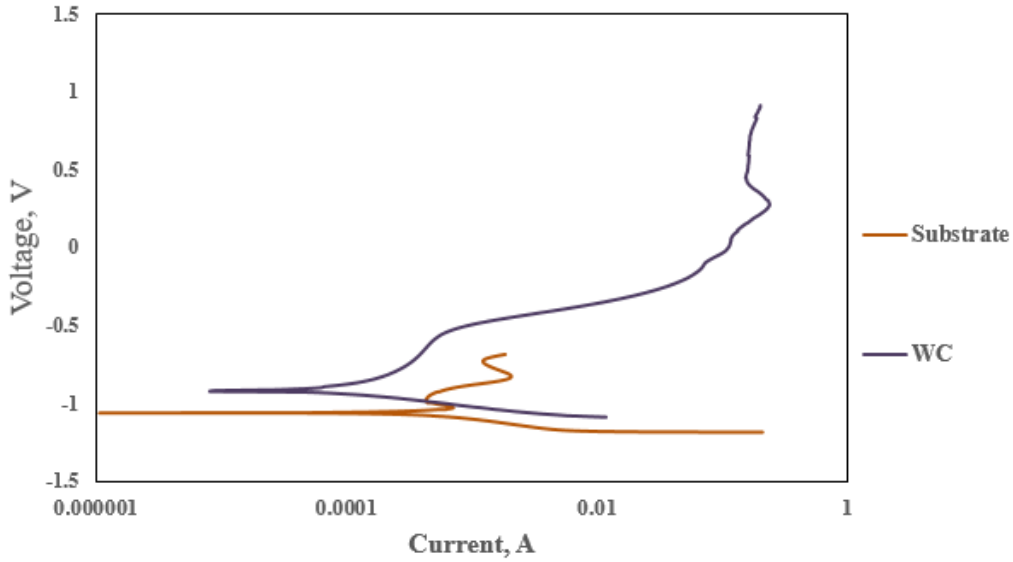
Figure 5.30. Tafel curves of HVOF WC coated and uncoated steel samples in 3.5% NaCl at 250°C.
