# CONCRETE PIPE AND SLIP-FORMED DITCHES FOR IRRIGATION IN A NORTHERN REGION

Harold Holmen and Howard M. Olson

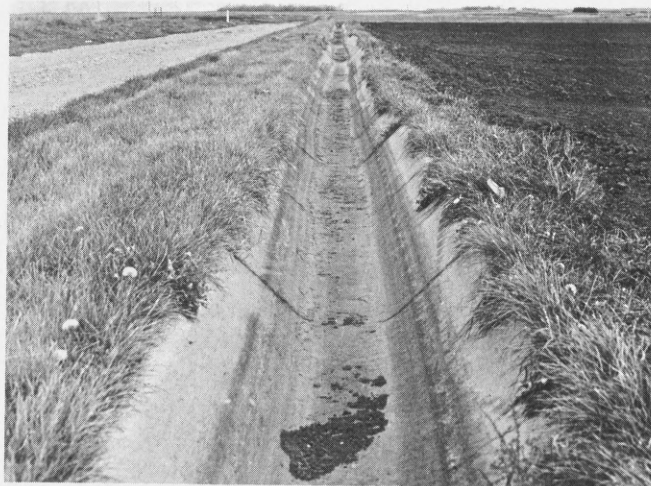
Downslope view to the southeast of the concrete, slip-formed ditch lining.

Lining was installed in the ditch using a slip-form machine designed for forming farm irrigation ditches. This method is illustrated by Laliberte, Rapp and Paziuk in Canadian Agricultural Engineering (2). An earth pad about one foot higher than the field was built and a ditch was shaped to conform to the slip-form machine. This produced a ditch three feet wide at the top with 1:1 sides and approximately 12 inches deep. The grade was 0.075 percent. Ready-mix concrete with a 2¾-inch slump was delivered to the site. The proper consistency of the concrete mix is very important for the machine to operate properly. As the slip-form was towed forward, a non-reinforced concrete lining approximately two inches thick flowed out behind the machine. Two test cylinders of the concrete were made, which failed at loads of 6,080

Construction joints were formed by pushing a 3/8-inch thick plywood template into the freshly placed concrete. Joints spaced 6, 8 and 10 feet were randomly placed along the length of the ditch. Finally, the entire lining was sprayed with a liquid curing compound.

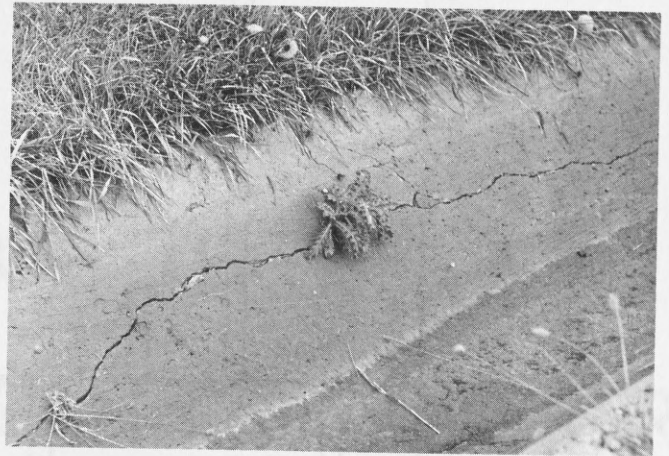
One of the longitudinal cracks that developed along the slip-formed concrete ditch lining.

In 1968, a longitudinal crack (crack parallel to centerline of ditch) appeared in a six-foot and in an eight foot section. By 1971, about 10 percent of the sections had longitudinal cracks. These cracks usually occurred at the base of the sloping sidewalls on either or both sides of the lining. Although more cracks appeared in the 10-foot sections than the six-foot sections, longitudinal cracking should be a function of the condition of the subgrade when the ditch lining was placed. The longitudinal cracks opened so that dirt accumul-

ed and weeds grew in them. These cracks could allow some rather severe seepage loss. Similar cracking believed to be caused by a high water table, has been noted in a slip-formed ditch near Hays, Alberta, Canada (2).
