# **APPENDIX A**

## **FIELD INVESTIGATION NOTES**

# Geomorphic Analysis Check List

Site Name: Lower Rush River - 1

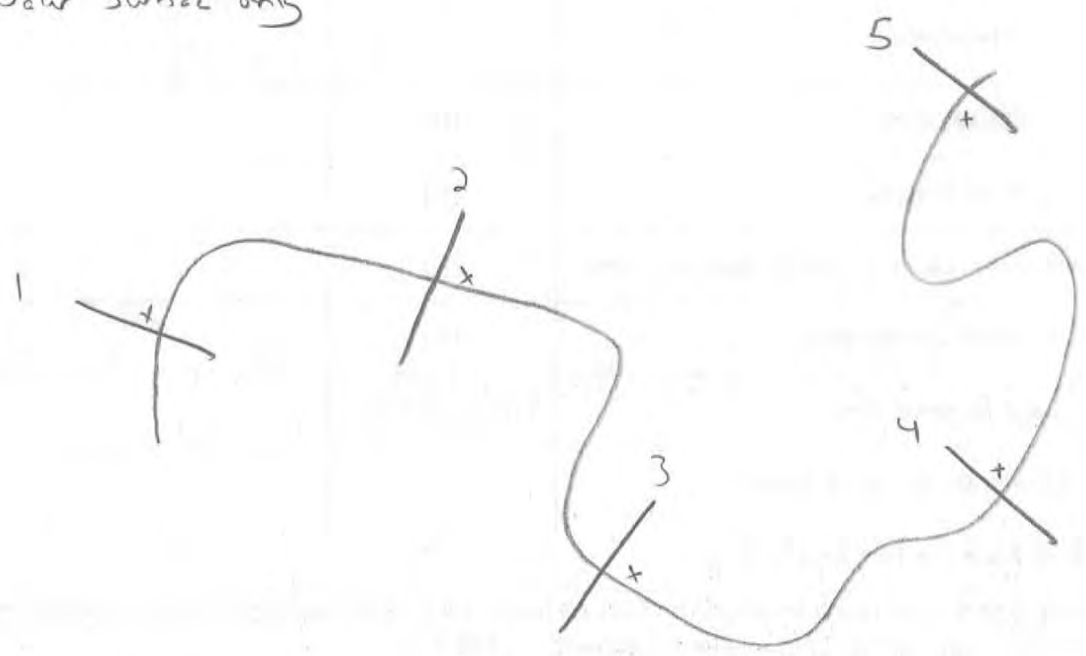
Date: 10/1/11

SKETCH Water Surface only

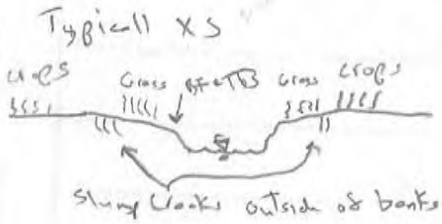
Note: Q measurement:  
measurement 18 @ dist 14 ft  
read 0.0 but should be 0.02

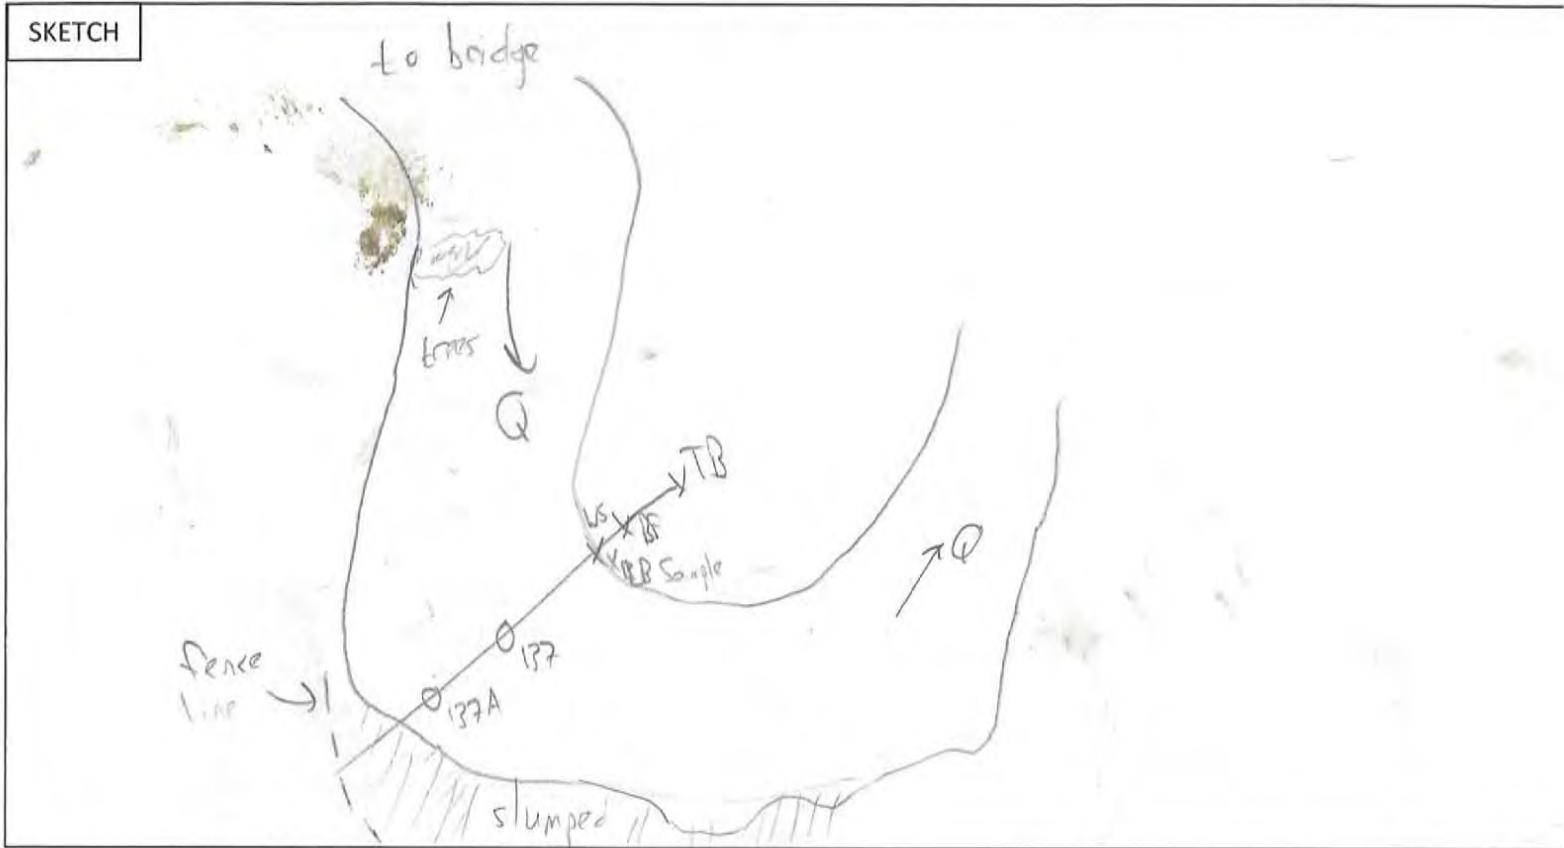
Site Name: Shoeyenne River @ 40<sup>th</sup> Ave Bridge (R/18.68 - 18.05)

Resided in 2011

Measurement	Unit	Value
Manning's n at Bank Full Condition	-	0.03
Root Depth	(ft)	2'
Root Density	(%)	25
Eroding Bank Surface Cover	(%)	3
Eroding Bank Length	(ft)	250'
Bank Material Type	(sand, silt, clay)	clay
Bank Material Stratification Score <sup>1</sup>	-	-
Distance from Bank Toe to Water Surface <sup>2</sup>	(ft)	2.3'

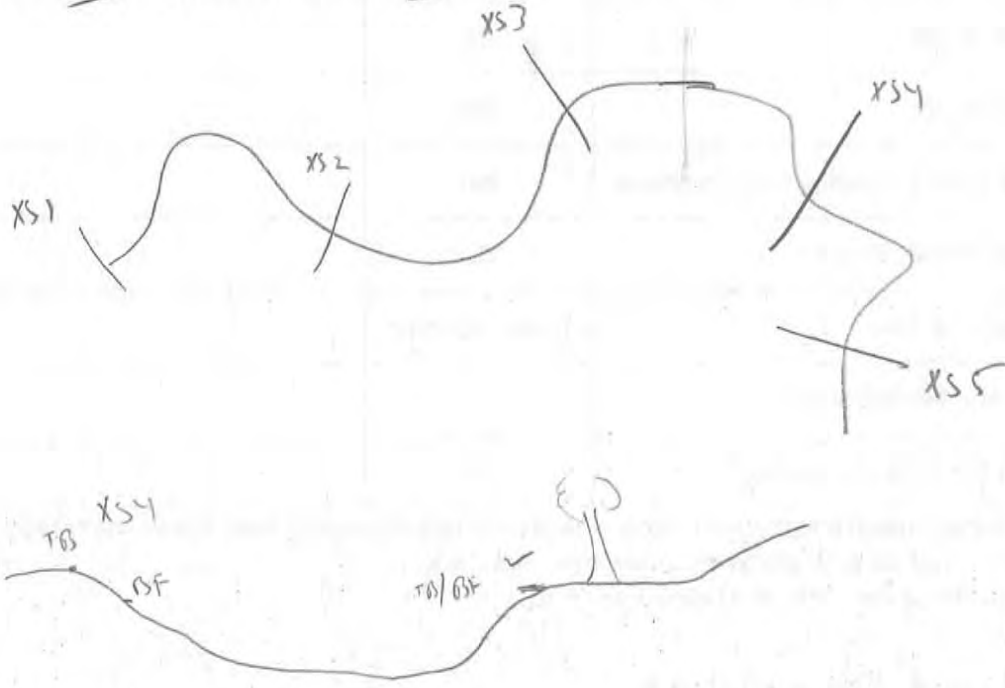
Date: 9/28/11

**SKETCH** Was scheduled for WS stakes but Q < 1 c/s. Staked 2 BF to clarify 2010 BF staking.

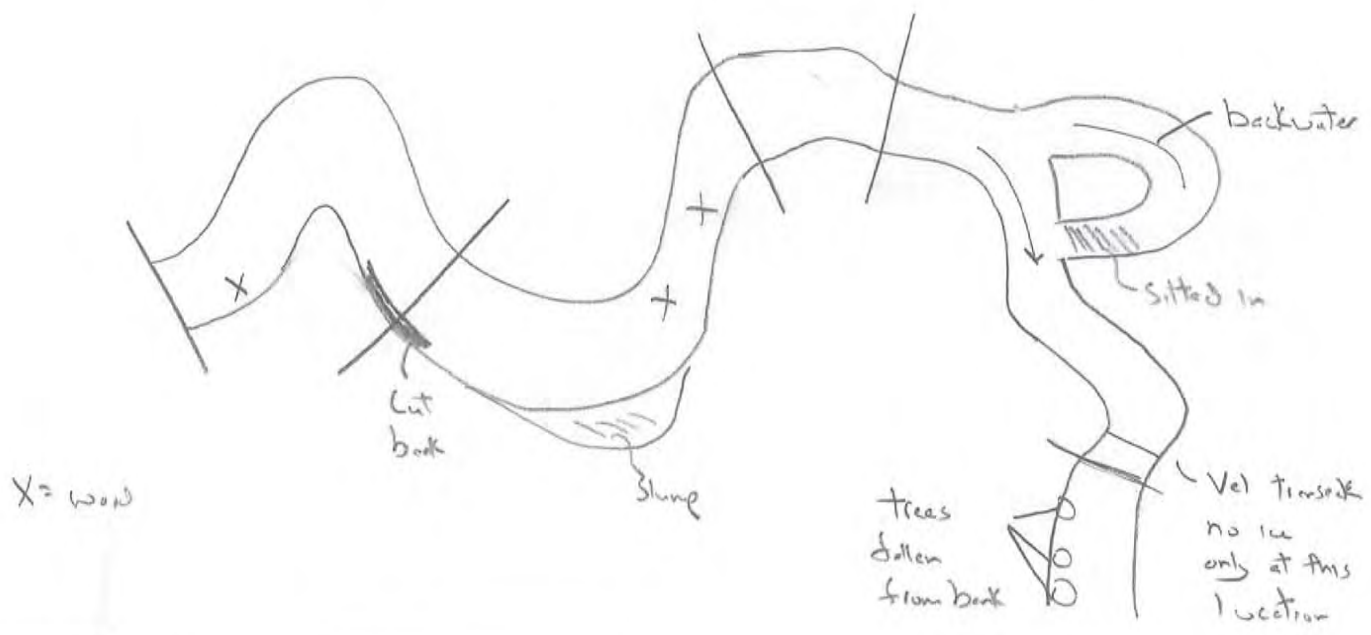
Site Name: Wolverton Crk 11/19/10 FID 21 (RMS.41-5.15)

Did not find.  
Did not mistake in 20 as Q=0

Measurement	Unit	Value
Manning's n at Bank Full Condition	-	0.04
Root Depth	(ft)	1-3 ft
Root Density	(%)	25%
Eroding Bank Surface Cover	(%)	5%
Eroding Bank Length	(ft)	700
Bank Material Type	(sand, silt, clay)	See Lab
Bank Material Stratification Score <sup>1</sup>	-	0
Distance from Bank Toe to Water Surface <sup>2</sup>	(ft)	> Frozen

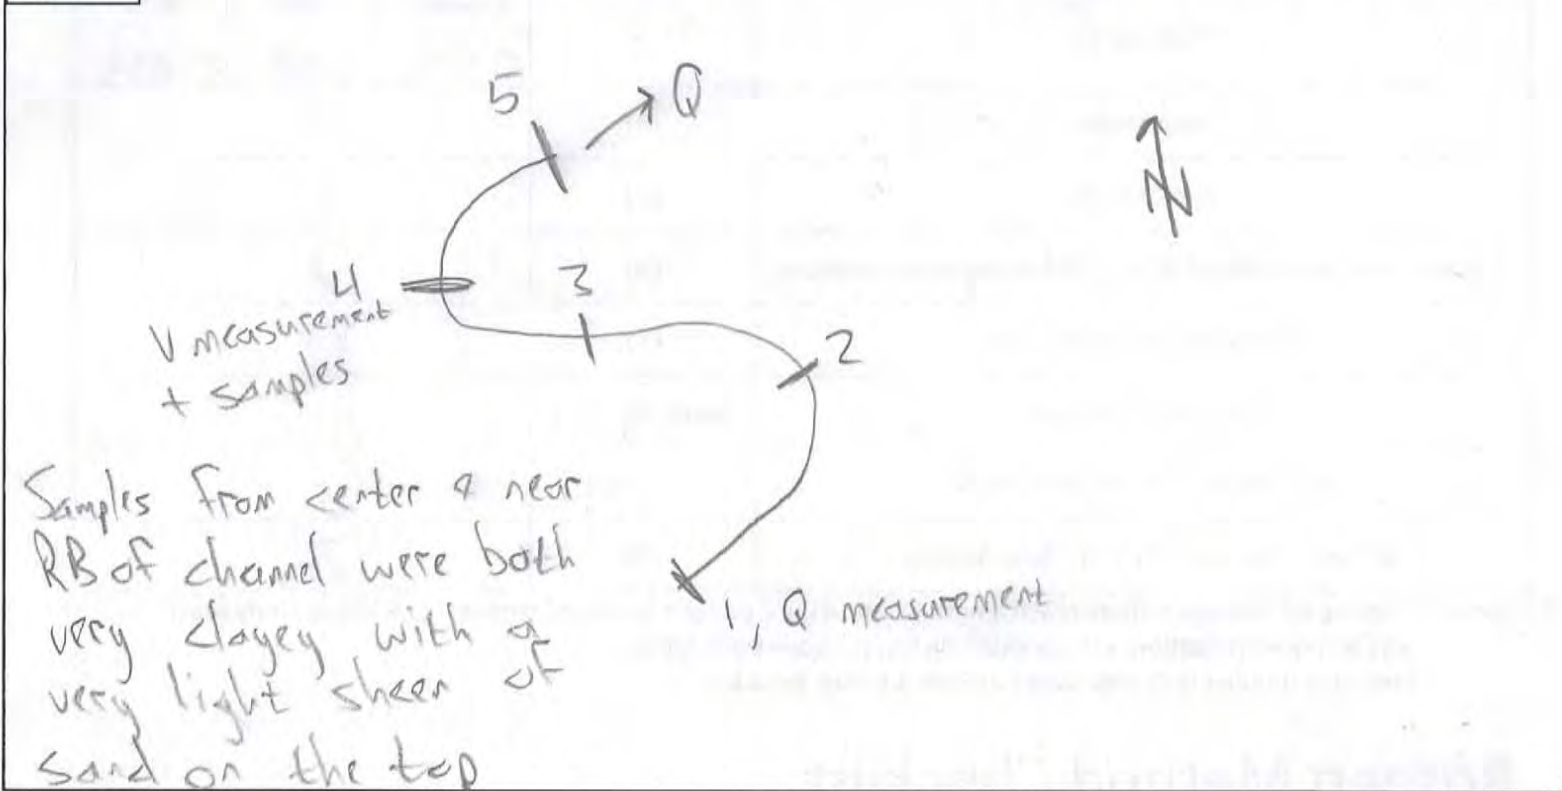
SKETCH

- follow recently mowed path to edge of water  
Date: 10/4/11

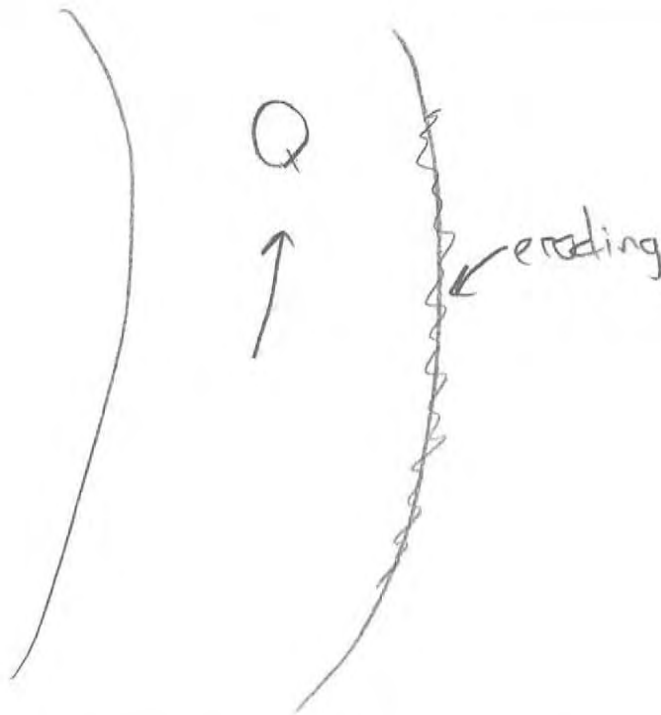
SKETCH

Site Name: Red River near Linderwood Dr.

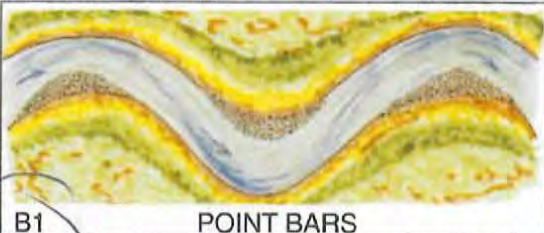
<p><b>B1</b> POINT BARS</p>

<b>Depositional Patterns</b>	
Stream: <u>Shayenne River</u>	Reach: <u>40th Ave Bridge</u>
Observers: <u>KDJ</u>	Date: _____
List ALL CATEGORIES that APPLY <input checked="" type="checkbox"/> <u>B1</u> <input type="checkbox"/> <input type="checkbox"/> <input type="checkbox"/> <input type="checkbox"/> <input type="checkbox"/> <input type="checkbox"/>	
<i>Various Depositional Features Modified from Galay et al. (1973)</i>

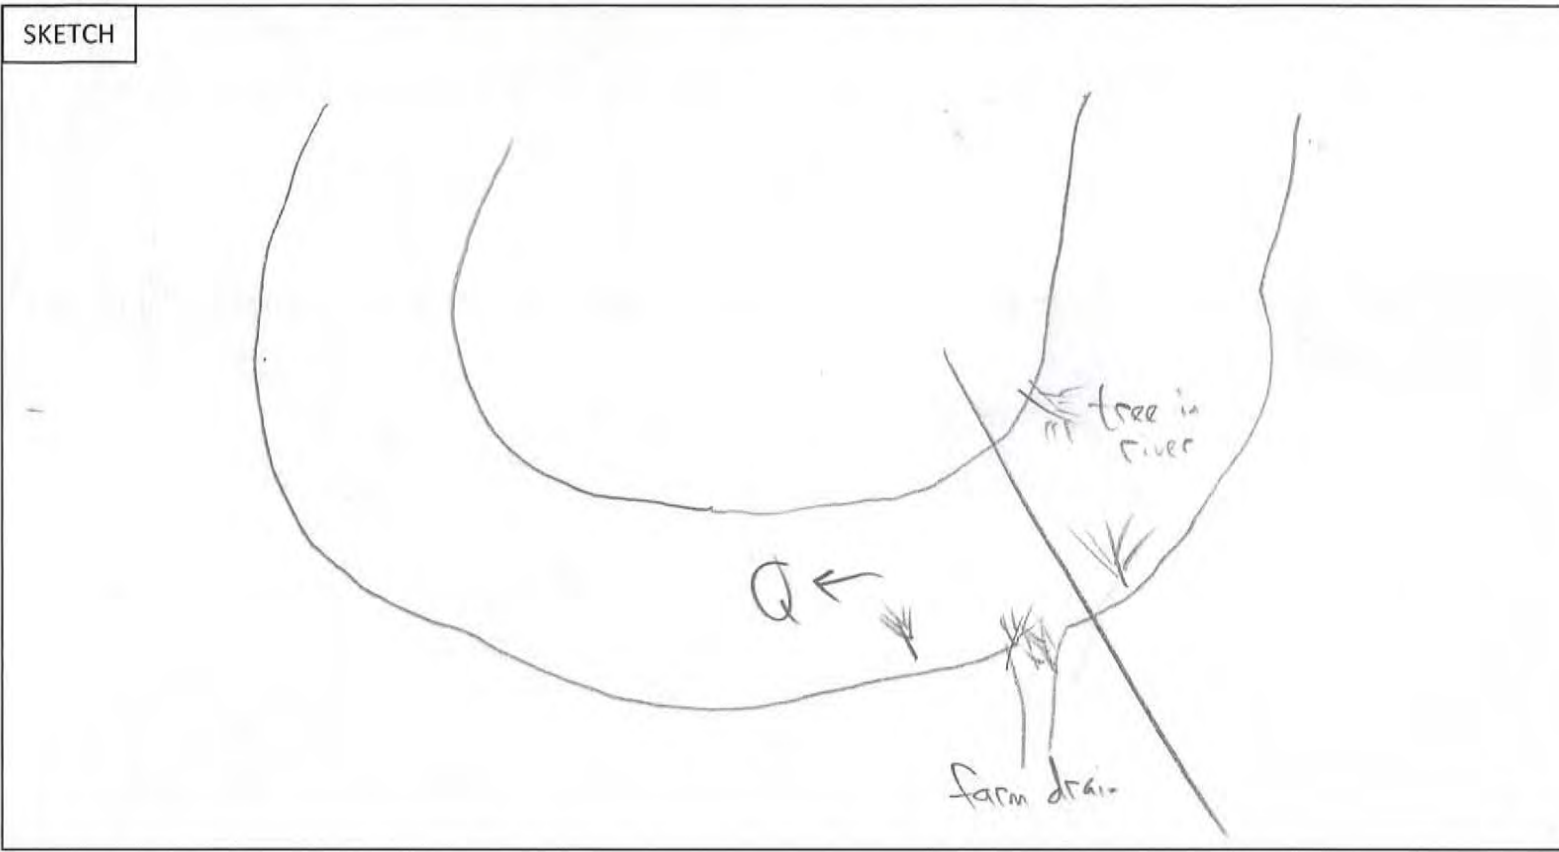
Site Name: Red River Upstream of Wild Rice

Measurement	Unit	Value
Manning's n at Bank Full Condition	-	0.03
Root Depth	(ft)	2'
Root Density	(%)	5
Eroding Bank Surface Cover	(%)	5
Eroding Bank Length	(ft)	450
Bank Material Type	(sand, silt, clay)	silt/clay
Bank Material Stratification Score <sup>1</sup>	-	-
Distance from Bank Toe to Water Surface <sup>2</sup>	(ft)

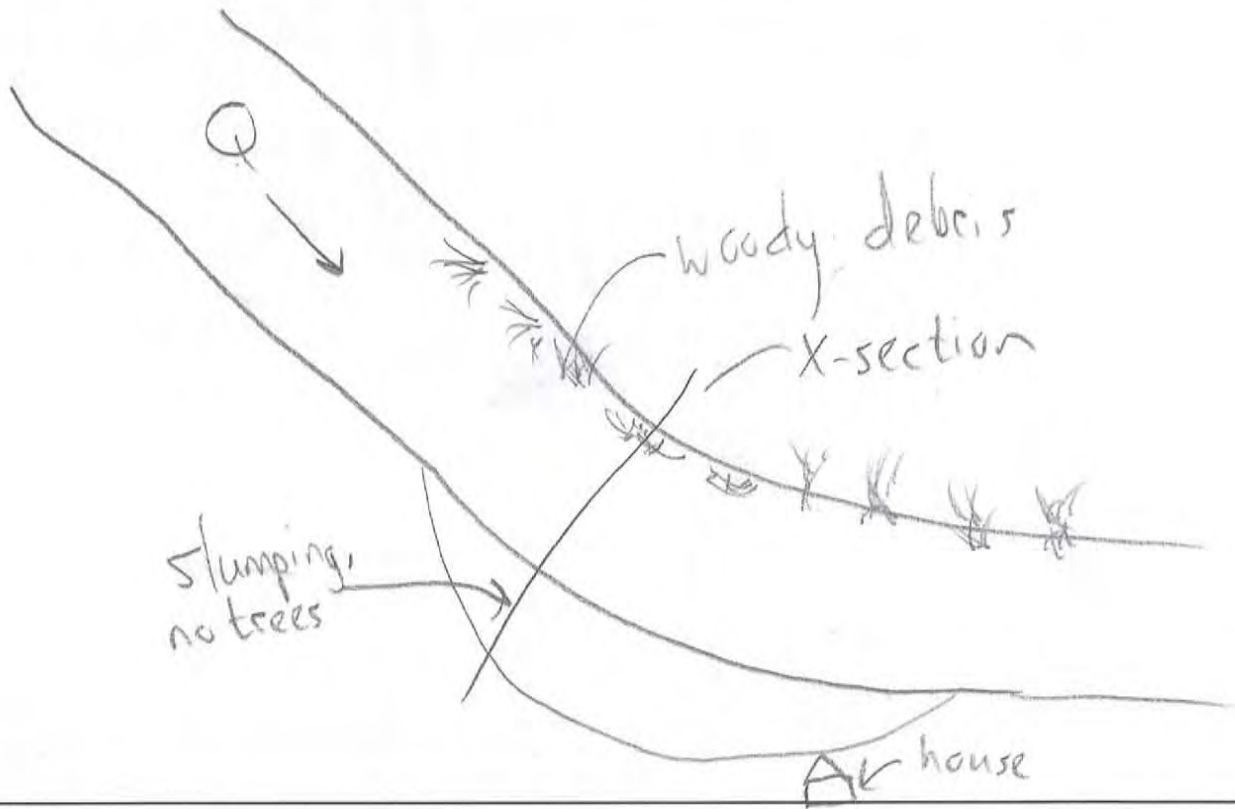
Site Name: Red River ~2mi W/S of 52<sup>nd</sup> Ave Boat Launch

Measurement	Unit	Value
Manning's n at Bank Full Condition	-	0.035
Root Depth	(ft)	1'
Root Density	(%)	5%
Eroding Bank Surface Cover	(%)	90%
Eroding Bank Length	(ft)	~350'
Bank Material Type	(sand, silt, clay)	silt silt/clay
Bank Material Stratification Score <sup>1</sup>	-	-
Distance from Bank Toe to Water Surface <sup>2</sup>	(ft)	3.2'

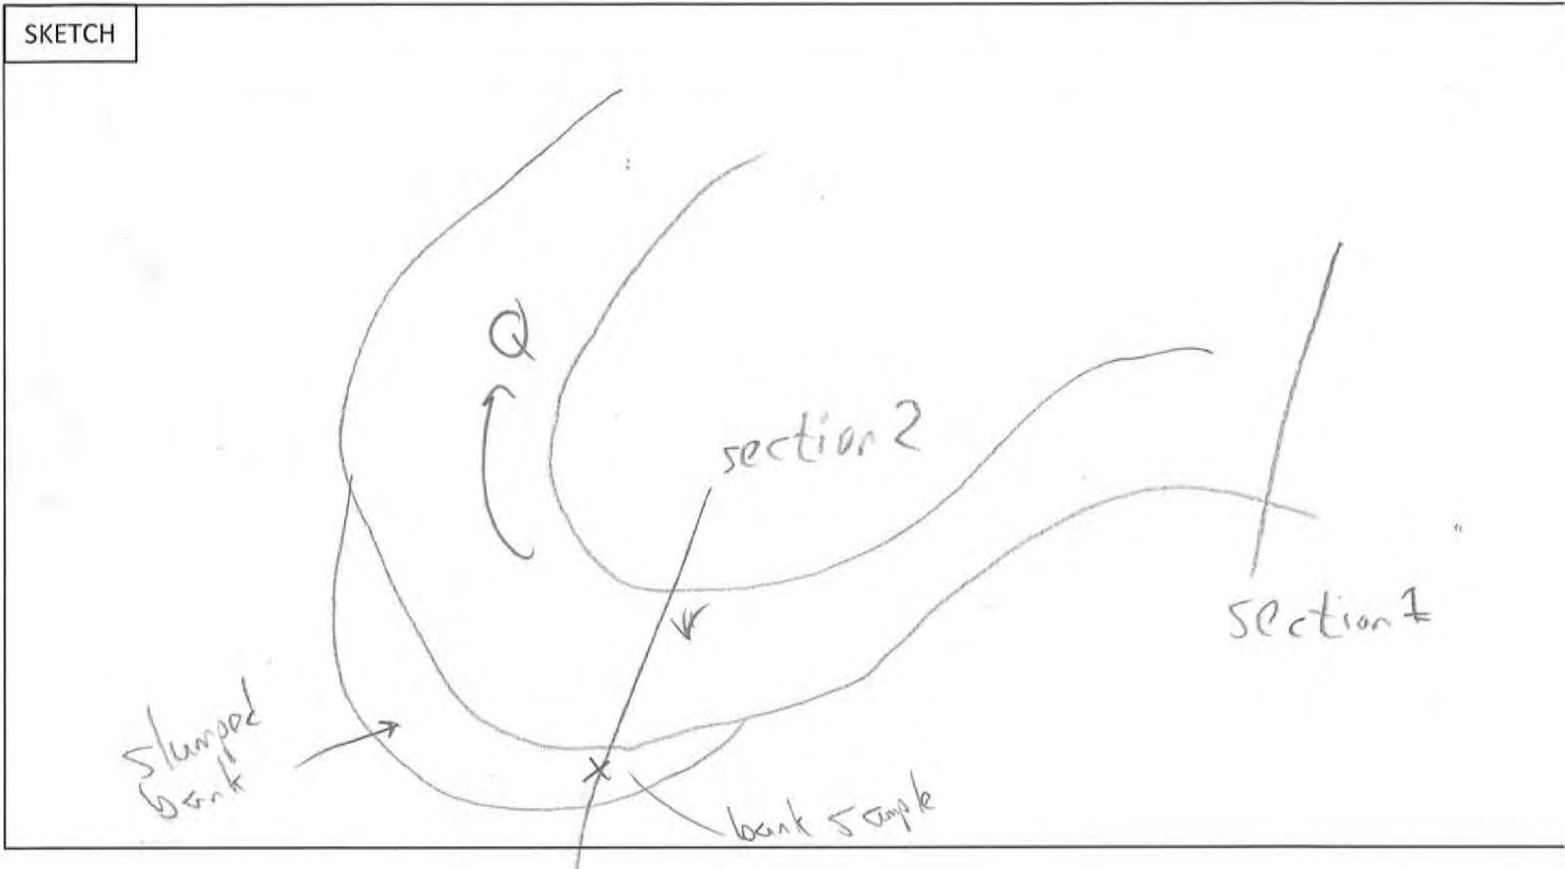
Site Name: Sheyenne River west of I-29, Exit 54

Measurement	Unit	Value
Manning's n at Bank Full Condition	-	0.03
Root Depth	(ft)	1'
Root Density	(%)	5%
Eroding Bank Surface Cover	(%)	15%
Eroding Bank Length	(ft)	325'
Bank Material Type	(sand, silt, clay)	silty clay / clay
Bank Material Stratification Score <sup>1</sup>	-	-
Distance from Bank Toe to Water Surface <sup>2</sup>	(ft)	2.3'

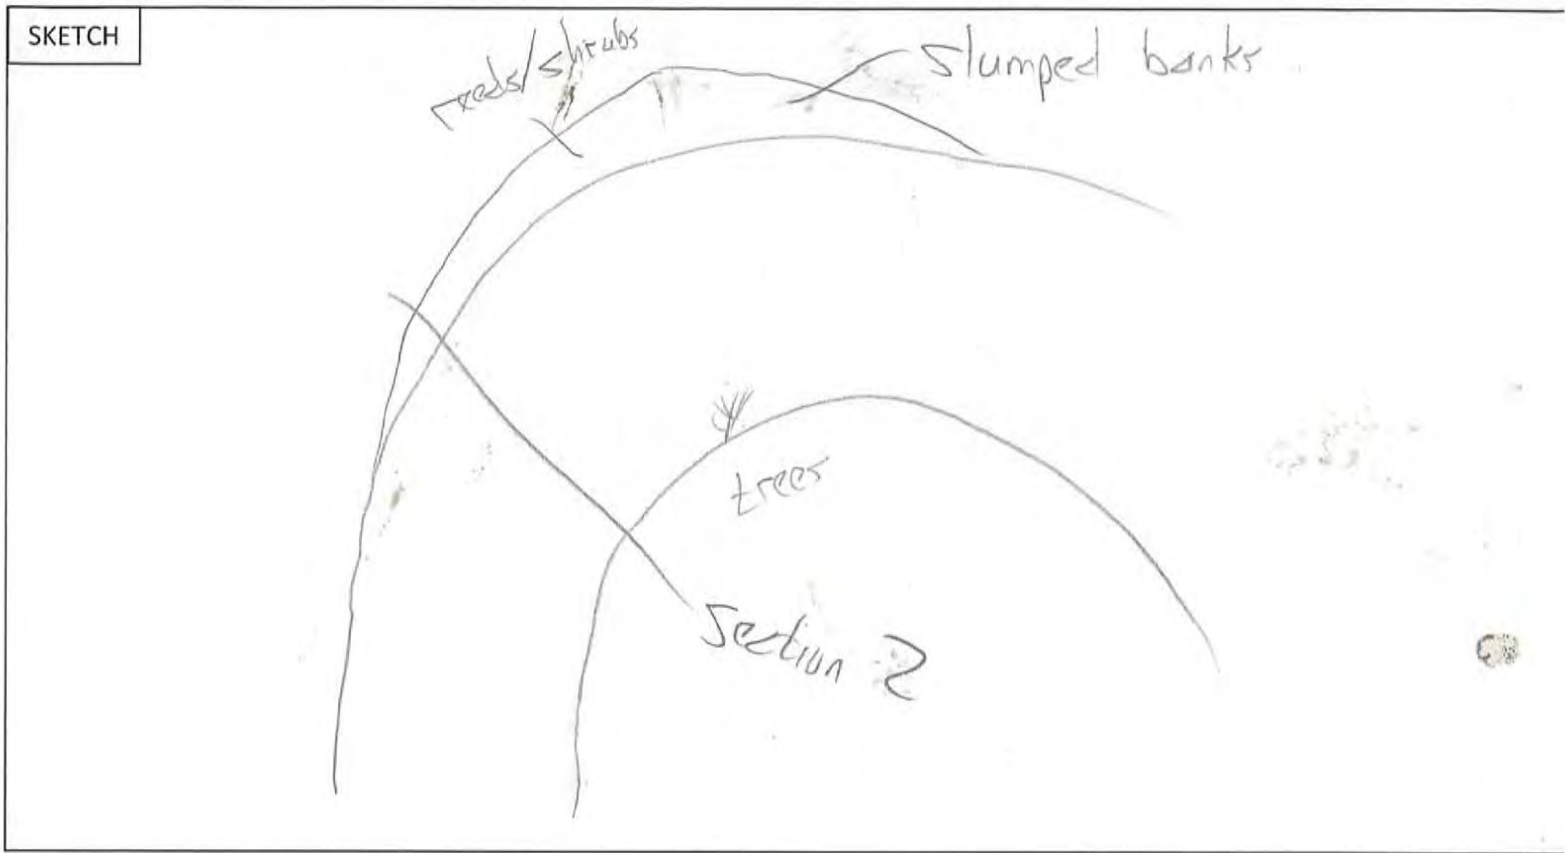
Site Name: Red River U/S of 4th Ave Bridge

Measurement	Unit	Value
Manning's n at Bank Full Condition	-	0.03
Root Depth	(ft)	1ft
Root Density	(%)	30
Eroding Bank Surface Cover	(%)	90
Eroding Bank Length	(ft)	~625 ft
Bank Material Type	(sand, silt, clay)	silt/clay
Bank Material Stratification Score <sup>1</sup>	-	-
Distance from Bank Toe to Water Surface <sup>2</sup>	(ft)
