Long Term Performance of a Sunflower Oil/Diesel Fuel Blend

M. ZIEJEWSKI AND K. R. KAUFMAN

The purpose of this project was to study the effects of a 50 percent blend by volume of sunflower oil in #2 diesel fuel used in a diesel test engine of current design. Specifically, this investigation covered the effect of the fuel blend on engine durability and the functioning of the different fuels in the diesel engine injection system.

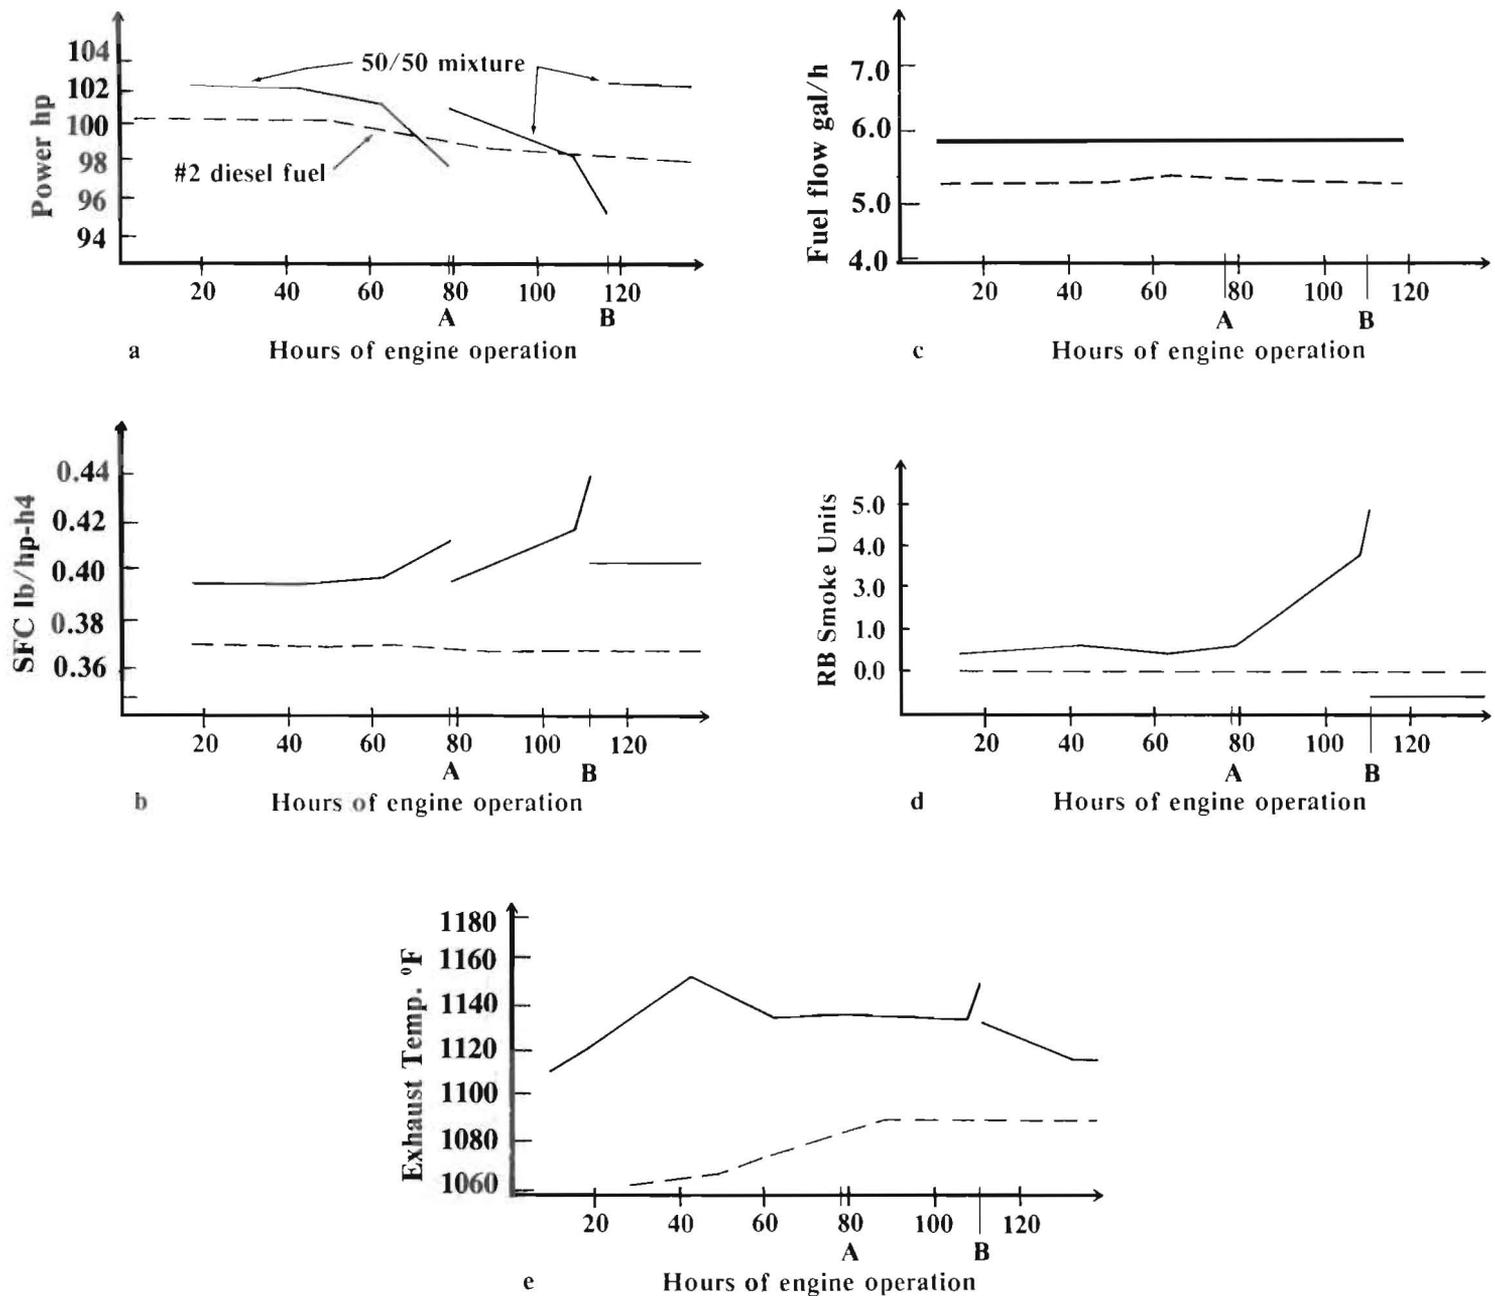
At the start of the 50/50 blend test, the power output was 3 percent higher and fuel flow was 13 percent higher than for #2 diesel fuel. This translated to a 6 percent increase in specific fuel consumption (SFC). In addition, exhaust temperature was 5 percent higher for the 50/50 blend. As the tests proceeded, engine performance losses were observed. The injection nozzles were changed when power loss did not allow the engine to continue on the test cycle. As can be seen in Fig. 2, engine performance loss between 60 and 79 hours was caused by fuel filter plugging. After changing the filter element at 79 hours of engine operation, the power output and fuel flow increased. Changing the injection nozzles after 112 hours of operation increased the power output to the initial level, decreased the smoke level, and decreased the exhaust gas temperature. A reduction in SFC was caused by increased power output because the fuel flow did not change. The outcome was similar for the other replaced injection nozzle sets.

The major problems with the injection nozzles were a drop in the nozzle opening pressure and abnormal carbon buildup. On initial installation, nozzle opening pressures were adjusted within close limits (about ± 1.0

Fig. 2—Effect of injection nozzle operating time on engine power, specific fuel consumption (SFC), fuel flow, exhaust gas temperature, and smoke level at 2300 RPM with a 50/50 mixture of sunflower oil and diesel fuel. Point A indicates fuel filter replacement. Point B indicates injection nozzle replacement.

percent) of the nominal pressure setting of 4250 psi. The nozzle operating time with the blend varied from 5 hours to 123 hours. During this time the nozzle opening pressure dropped about 10-15 percent as a result of the nozzle springs taking a set; there was slight wearing of various valve, spindle, and spring contact surfaces; and carbon deposits formed on the seat and needle. The highest drop in nozzle opening pressure was almost 20 percent. The loss of opening pressure for all nozzles was not equal, which affected fuel distribution between cylinders.

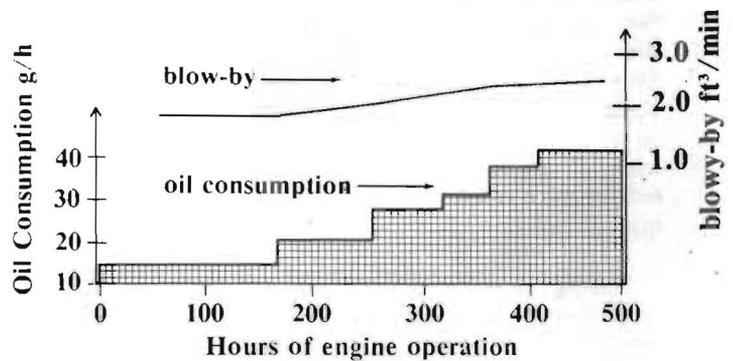
8a. #2 diesel fuel

The lubricating oil consumption for the 500 hour test on #2 diesel fuel was very good (0.00051 lb/hp-hr), (Fig. 8). For the 604 hour test on the 50/50 blend, the mean oil consumption was even better (0.00020 lb/hp-hr), (Fig. 8). The lubricating oil analysis (high percentage of total solids and high viscosity) suggests that combusted and noncombusted fuel may have traveled between the piston and cylinder wall into the crankcase causing the apparent low lubrication oil consumption rate.

Blowby stayed at a satisfactory level most of the time during the engine test on the 50/50 blend (Fig. 8). The only reading that showed increased blowby occurred at 200 hours. At this time, the blowby had increased from 2.7 cfm to 4.4 cfm (75 L/min to 125 L/min). This was most likely caused by a temporary loss of sealing of the piston rings.

Fig. 8—Oil consumption and blowby while using #2 diesel fuel or a 50/50 sunflower oil/diesel fuel mixture (measured at 75 kW).
