## *Grassed Waterways Stop Gullies, Also Produce Valuable Hay Crop*

By T. J. Conlon<sup>1</sup>, R. J. Douglas<sup>2</sup> and W. C. Whitman<sup>3</sup>

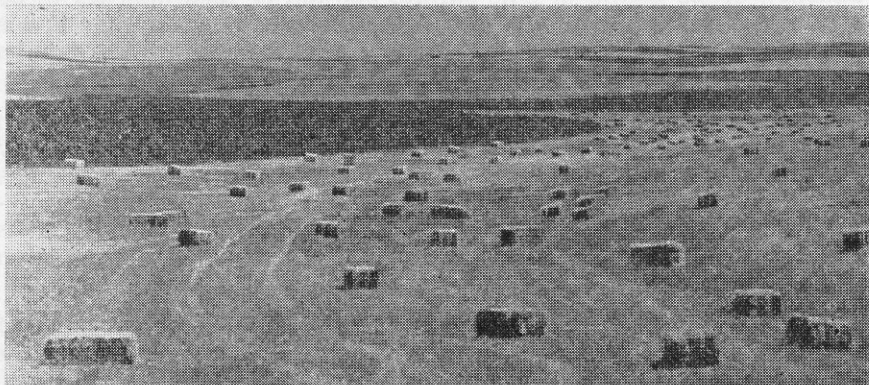
FIGURE 1.—Baled hay on the new grassed waterway at the Dickinson Station in 1955. (Photo by W. P. Sebens).

The badly gullied waterway, well over one-half mile long, on land obtained in 1951, was for all practical purposes waste land at that time because it was too rough to permit the operation of hay making machinery.

The strip was surveyed by local Soil Conservation Service personnel, and levelling, filling and grading operations were carried out in the spring of 1954 to produce a flat bottom bed 40 feet wide with gently sloping sides. The strip was seeded, as soon as grading was completed, to a mixture of five pounds bromegrass, four pounds intermediate wheatgrass and three pounds alfalfa, with a light seeding of oats for a cover crop. The hay crop harvested in 1955 was estimated at three tons per acre.
